REFURBISHMENT STRUCTURAL STRENGTHENING WITH SIKA SYSTEMS

FOR OWNERS OF BUILDINGS AND CIVIL ENGINEERING STRUCTURES

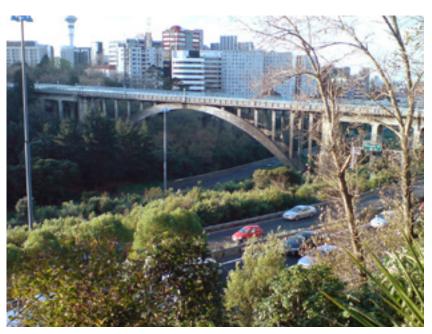
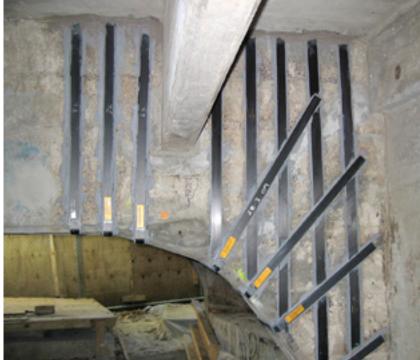
Sika CarboDur® strips and CarboShear L plates bonded to the concrete structure.

Sika CarboDur® CFRP plates were installed on the underside of the reinforced concrete beams to provide additional mid-span movement resistance. The Sika CarboShear L shaped CFRP profiles were then installed, in pairs, around the beams and up into the deck slab to improve the shear performance.

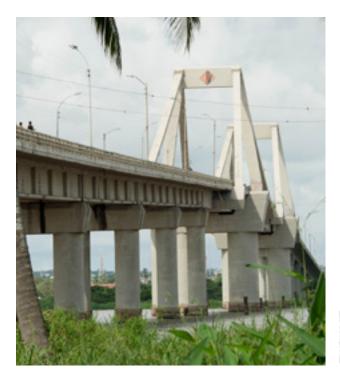
Few years after the initial concrete repair works were completed shear cracks were noticed in the beams and the requirement for structural strengthening was decided by the Engineers. After sealing and filling the cracks with Sikadur® injection resin, the substrate was prepared and a lightweight SikaWrap® fabric strengthening system was applied in two directions and finally the areas were covered with a SikaTop® coating.

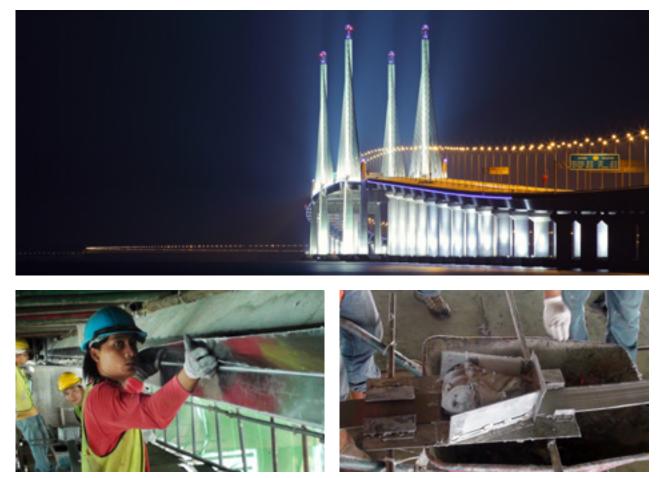
Installation CarboDur®

The damaged concrete was removed and the reinforced concrete beams were repaired with a SikaTop[®] concrete repair System and SikaGrout[®] poured concrete. The beams were then strengthened to the performance levels required by the System. Finally, all of the exposed concrete and CarboDur® plate surfaces were given a protective Sikagard[®] coating to protect them against UV light and future attack from the aggressive marine environment respectively.

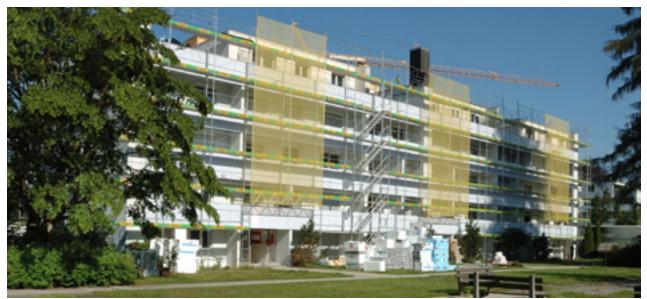
Anchorage of Sika CarboStress System

The Sika CarboStress® system was selected to achieve the necessary seismic resistance on the structure. This consisted of post-tensioned Sika CarboDur® CFRP plates anchored into the substrate. In the three stairwells of the building, a total of 12 Sika CarboStress® tendons were installed. Since these Sika CarboStress® tendons were relatively small, flexible and could be

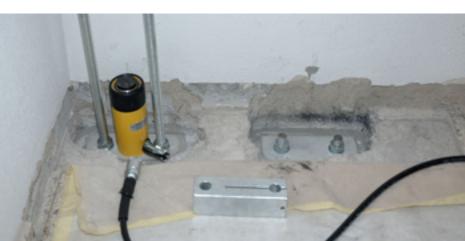
Pressure cylinder

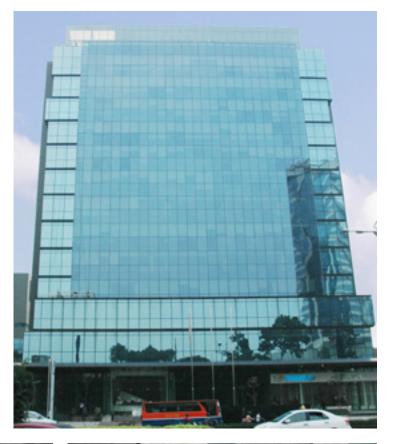
Beam strengthened without removing wall
CFRP installed around existing obstacles
Columns strengthened with SikaWrap® fabric
Reinforcement of beam with CFRP

The Engineers selected a Sika structural strengthening solution with carbon fiber-reinforced polymer (CFRP) materials, because of its effective performance despite its lightweight characteristics. Furthermore, the Sika systems allowed flexibility on site to overcome any issues and were easy to apply. The columns in the basement and ground floor were strengthened to provide increased confinement with the SikaWrap® fabric strengthening system. The cross beams were then either strengthened in flexure and against shear, or against shear only, by using a combination of Sika CarboDur® CFRP plates and SikaWrap® fabrics, with up to three layers of the fabrics being applied. During the installation works on site unforeseen conditions, including walls that could not be removed and voids in the existing concrete, were found. Another advantage of these Sika strengthening solutions was then that their design can be adjusted accordingly, so the works could still be completed successfully and with minimal break-out or removal of sound materials on site.

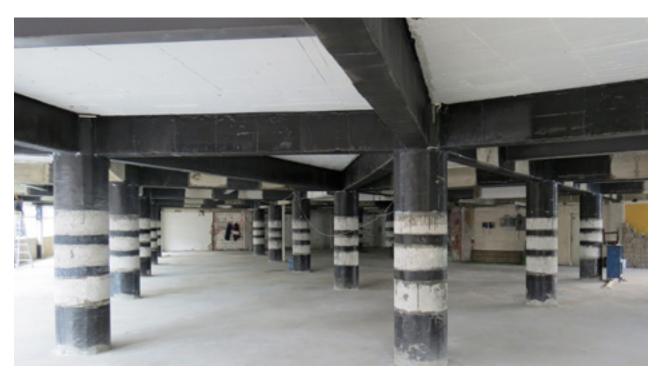
Beams and collums strenghtened with SikaWrap®

Because the original building design details and calculations no longer existed, a series of diagnostic studies were performed, including research on soil mechanics in the area, steel reinforcement location and assessment, concrete condition survey, and an overall visual inspection; followed by 3-dimensional computer modeling with the results for dynamic structural analysis. These revealed that in the event of a seismic event the concrete floor slabs exhibited deflection and excessive vibration resulting in cracking, the supporting beams exhibited shear cracking at their ends and the non-structural masonry walls interfered with the free deformation of the main structure. Furthermore, the computer modelling also revealed that the main support columns were overloaded. A number of steps were then taken to refurbish and upgrade the whole building, including additional steel bracing and casting additional concrete, sealing existing cracks by injection and then overall structural strengthening. The beams were strengthened in flexure and shear using the SikaWrap® fabric strengthening system, the columns had continuous Sika CarboDur® CFRP plates installed along their axis over several storeys, then the columns were also wrapped with SikaWrap® fabric to increase their strength and ductility. The complete refurbishment project was easily completed on time due to the lightweight nature and rapid installation procedure for these Sika systems. The weight of the structure was only slightly increased, and no useable area was lost.

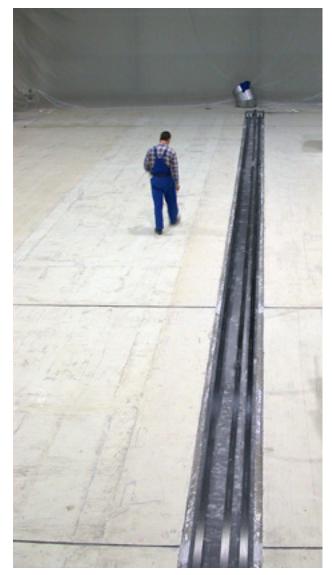
The longest post-tensioned CFRP-plates ever installed

System. Three tendons, consisting of CarboDur[®] plates and special end anchorage heads were installed to produce a united base without joints. The CFRP plates were then encapsulated into the concrete base to protect the system and to make the area ready for use.

With 29 m this is the one of the longest post-tensioned CFRP plates ever installed in the world.

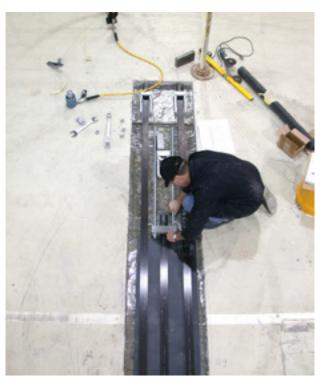
Plate and end-anchorage

Base channel with post-tensioned CFRP plates

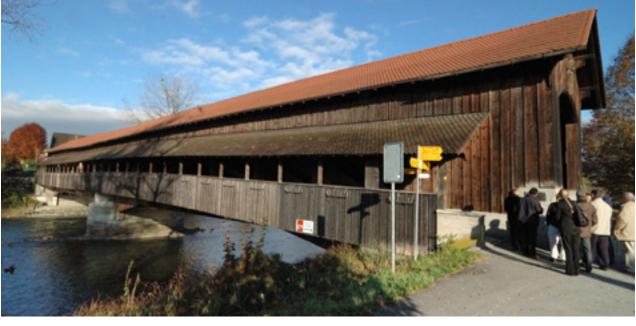
CarboDur® strenghtened crossbeam

Bottom view of strenghtening system

Today, the bridge also serves as a back-up route for heavy vehicles, and the required loading is 20 tons. The residents opposed an option to replace the historic bridge with a new structure, so overall refurbishment and strengthening to upgrade the whole structure was carried out in 1991. The structural strengthening of this timber bridge was also part of a long-term study and it was one of the first Sika CarboDur[®] strengthening projects on wooden structures. The system was selected for its excellent mechanical properties and minimal visual impact, as retaining the visual appearance of the bridge was also a key decision factor. To refurbish the bridge the deck was removed and rebuilt, and Sika CarboDur[®] CFRP plates were bonded to the bottom of the crossbeams to reduce deflection. The installed plates were left exposed and uncoated to facilitate inspection and assessment, but to date the installation remains maintenance free.

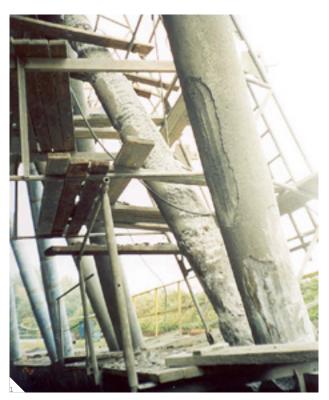
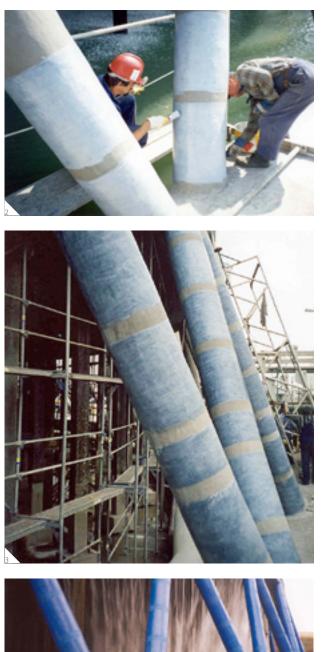
Damaged colums
Application of SikaWrap[®]
Installed strengthening system
Coated strengthening system

On 92 of the main supporting columns the concrete had spalled-off over corroding reinforcement in several areas, the steel was then exposed and continuing to corrode and lose significant cross section. The structure therefore now needed not only concrete repair and replacement on the damaged columns, but also a structural strengthening solution to reverse the loss of strength resulting from the corrosion and damage.

After removal of all damaged concrete and preparation of the surfaces, selected columns were repaired with sprayed concrete based on Sikacrete[®] admixture. The rest of all together 92 columns was then reprofiled with the Sika MonoTop[®] repair system and sealed with a Sikagard[®] impregnation. When the repairs were hardened the necessary confinement strengthening was carried out using SikaWrap[®] fabric in sections. Finally, all of the surfaces were overcoated with a Sikagard[®] protective coating for improved appearance and additional durability.

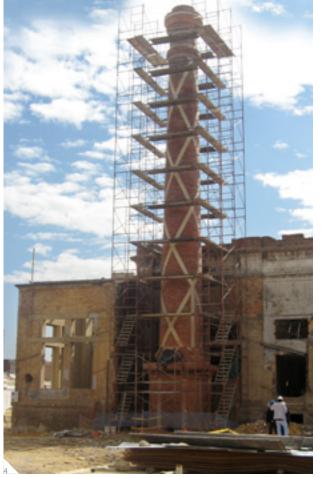
1 Substrate levelling 2 SikaWrap® roll 3 Installation of SikaWrap® 4 Coated strengthening system

After some years the complex declined and eventually was abandoned for several decades until the University Distrital bought the buildings in 2010 with the objective of developing and converting them into a cultural center. The masonry chimney was considered to be a heritage structure and had to be retained. Whilst built in good quality unreinforced masonry (URM) originally, it now needed upgrading and strengthening to be in-line with the current Colombian Seismic Construction Code. A structural strengthening system was therefore required, and one that would also preserve the aesthetics and appearance of the structure. A complete Sika solution was selected. After cleaning the structure thoroughly, Sikadur[®] epoxy mortar was applied to level the surfaces and prepare them for application of the SikaWrap[®] fabric strengthening system. SikaWrap[®] fabric strips were then cut to size and applied symmetrically, both diagonally and vertically, to improve the strength of the whole chimney structure with a uniform appearance. Finally the whole masonry chimney surfaces were overcoated with an acrylic protective coating.
