Waterproofing & protection of external pool, Rethymno, Crete

POOL WATERPROOFING & SURFACE PROTECTION: SikaTop®-129 Sunshine & Sika® Fibernet

EXTERNAL POOL WATERPROOFING & PROTECTION, RETHYMNO, CRETE

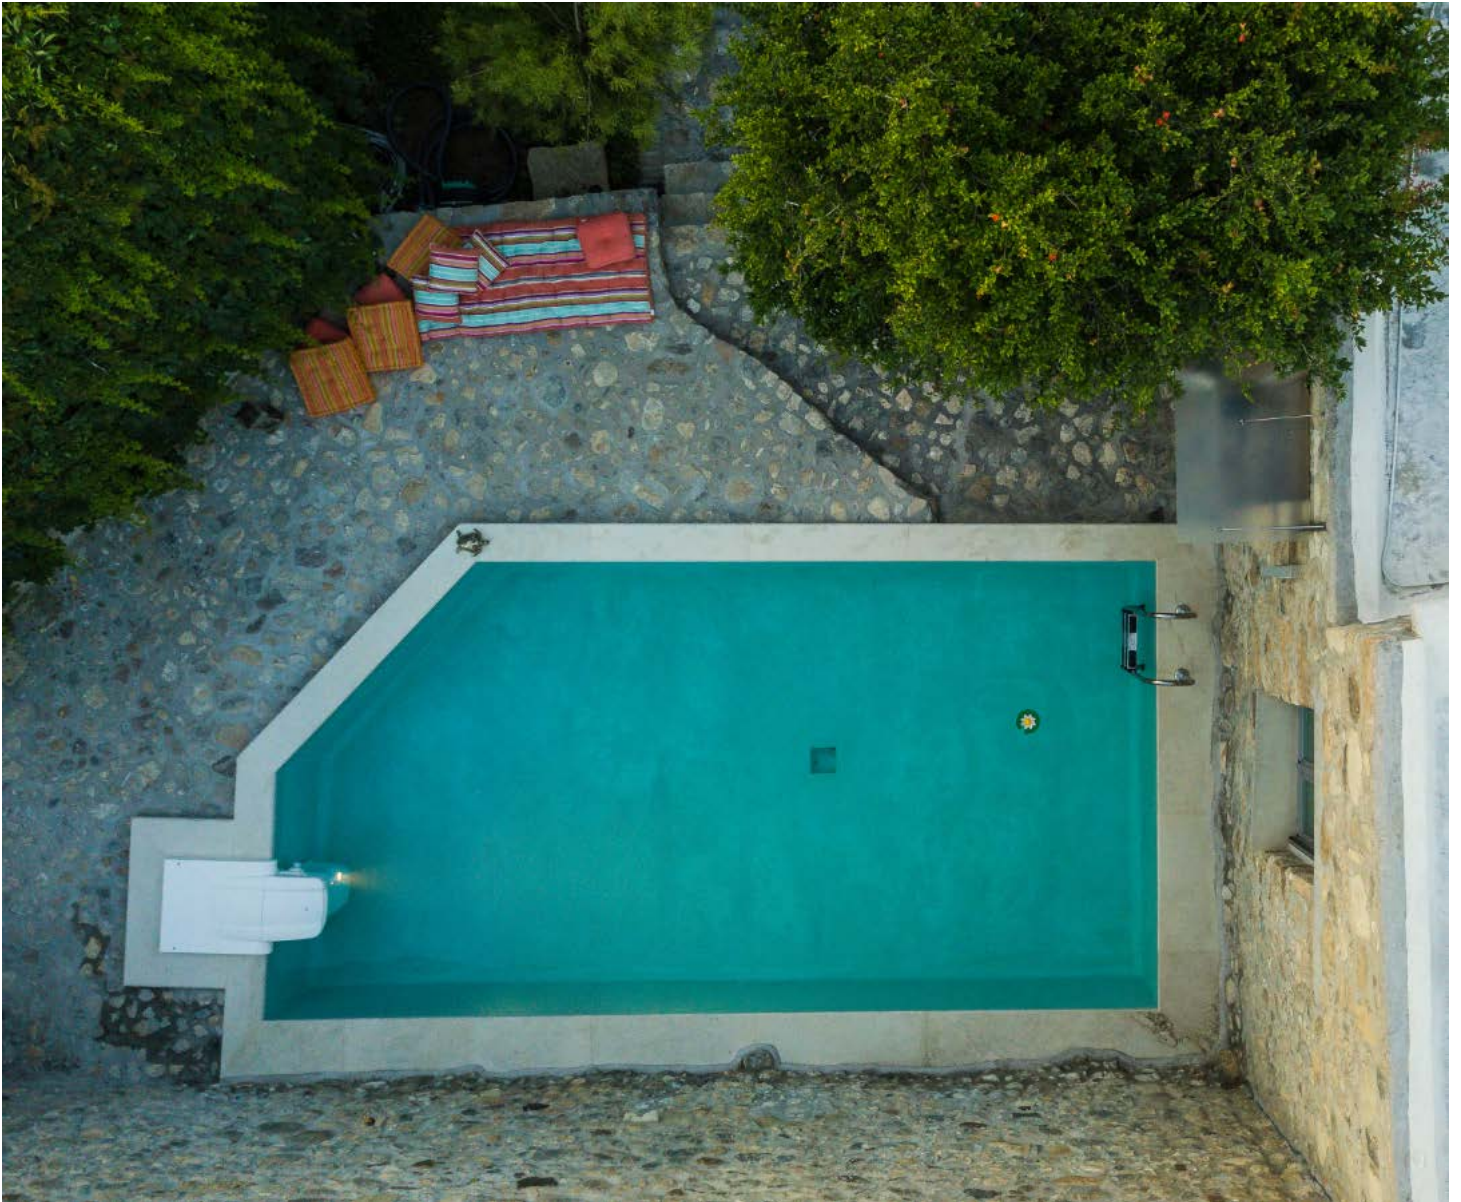
As part of the restoration of an existing 19th-century stone-built residence, its surroundings were designed to include an outdoor pool. The new pool had a total surface area of ~ 25 m² and would be a gem for the restored - now - private holiday home.

Initially, the surface was mechanically prepared, removing cement laitance, forming a suitable quality substrate.

After thorough mixing of the pre-weighed components of **SikaTop®-129 Sunshine**, application was performed with a notched spatula. On this first mortar layer, the **Sika® Fibernet** alkali-resistant glass fiber mesh was applied. **Sika® Fibernet** glass mesh was then fully embedded and coated by applying a second layer of **SikaTop®-129 Sunshine** mortar. As the mortar features excellent application properties on vertical surfaces (even on overhead surfaces), the same procedure was followed for all the vertical elements and the particular details of the swimming pool. The final finishing/smoothing was performed with a grinder, as soon as the mortar layer began to stiffen.
