SIKA AT WORK

Complete Sika systems for luxurious villa, Mykonos

COMPLETE SIKA SYSTEMS FOR LUXURIOUS VILLA, MYKONOS

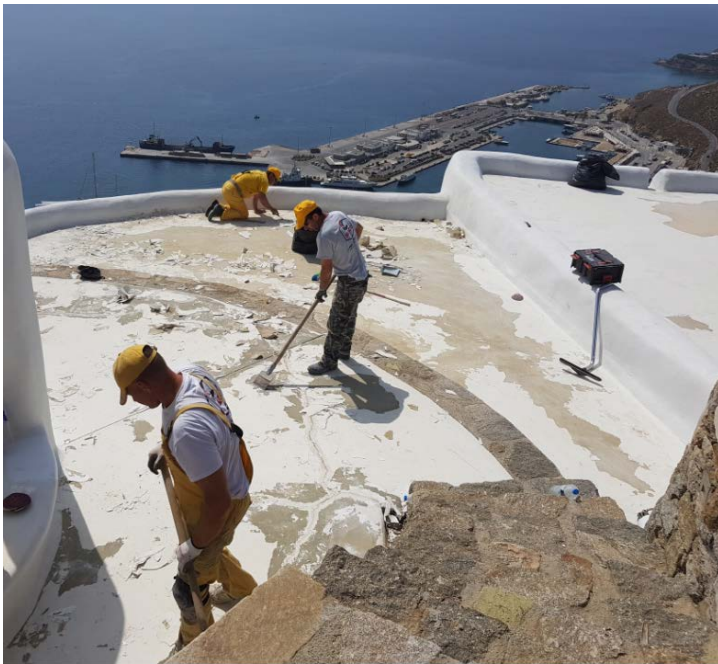
Roof waterproofing of surrounding area / roofs: Initially the surface was prepared by removing loose segments and applying the polyurea / polyurethane based primer **Sika® Concrete Primer**.

Its main advantages include the cure speed – overcoating is possible after 30 minutes - the significant reduction in the event of outgassing and the stabilization of dusty and friable substrates.

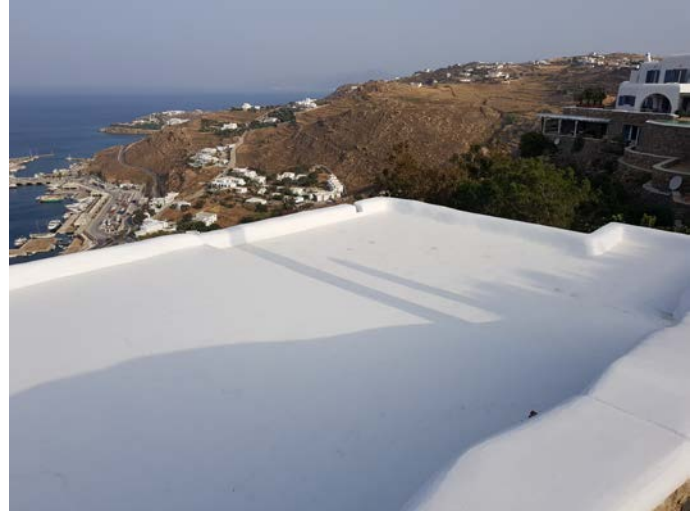
Then the application of the base coat followed, using the 1-component, **MTC®** polyurethane membrane **Sikalastic®-612**, into which the glass fleece **Sika® Reemat Premium** was embedded. **Sikalastic®-612** is easy to apply and the glass fleece embedment offers top dimensional stability against thermal fluctuations (day-night).

Sika’s **MTC®** systems describe liquid applied membranes based on a unique curing technology type, which is activated by moisture, but remains unaffected from it during curing. This means that these membranes can cure over a wide range of conditions, including extreme temperature and humidity fluctuations. Unlike conventional polyurethane liquid membrane systems, they do not release CO₂, which often causes foaming phenomena and their application is not affected by adverse environmental conditions.

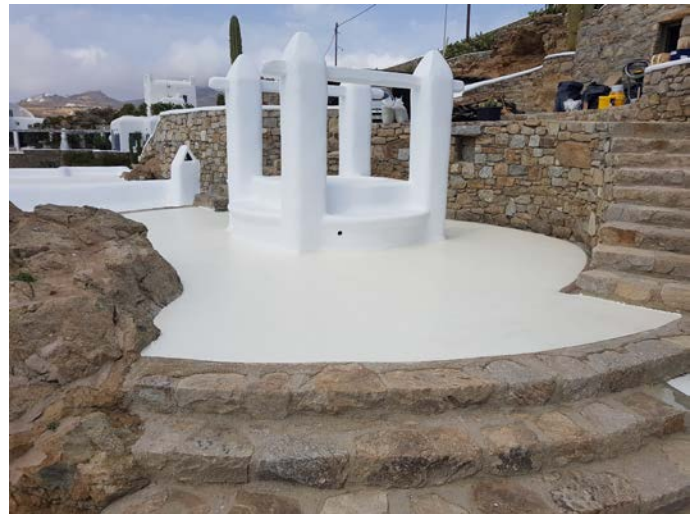
On the reinforced base coat the final, reflective coating **Sikalastic®-570 TC** was applied. **Sikalastic®-570 TC** is resistant against yellowing and UV radiation, while features high reflectivity properties (RAL 9016 – extra-white) and remains permanently elastic and offers crack bridging possibility.

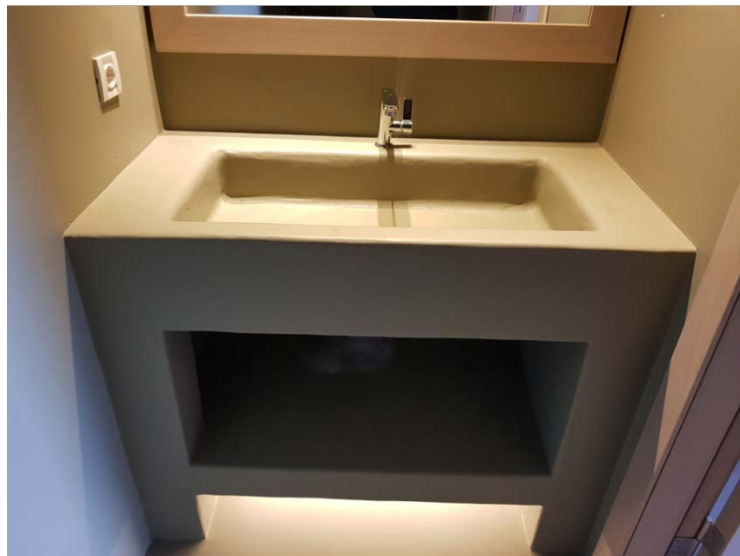
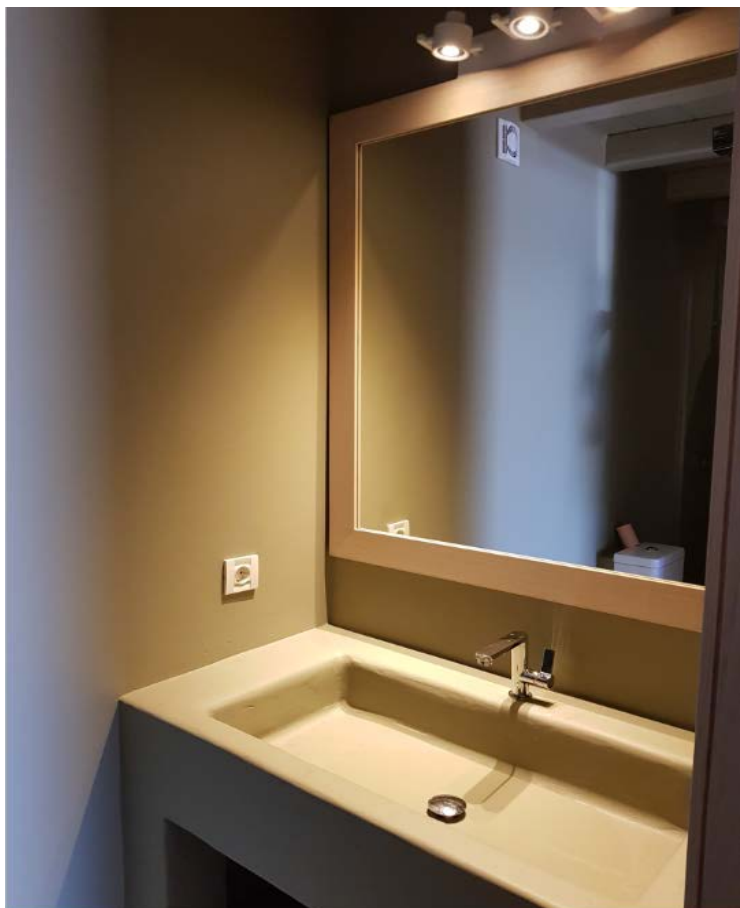
Cementitious decorative system for bathrooms: On the bathrooms of the villa, the **SikaDecor®** decorative, cementitious system was used, comprising of:

- Water based primer **SikaTop®-10** or **Sika® Primer-11 W**
- Decorative cementitious coating **SikaDecor®-801 Nature**, which can be mixed with pigments
- Polyurethane, 2-component, water based sealer **Sikafloor®-304 W**

Microcement, decorative system for bathrooms: For the bathrooms, the **SikaDecor®** system was used. **SikaDecor®** system is a high quality cementitious “screed” system.

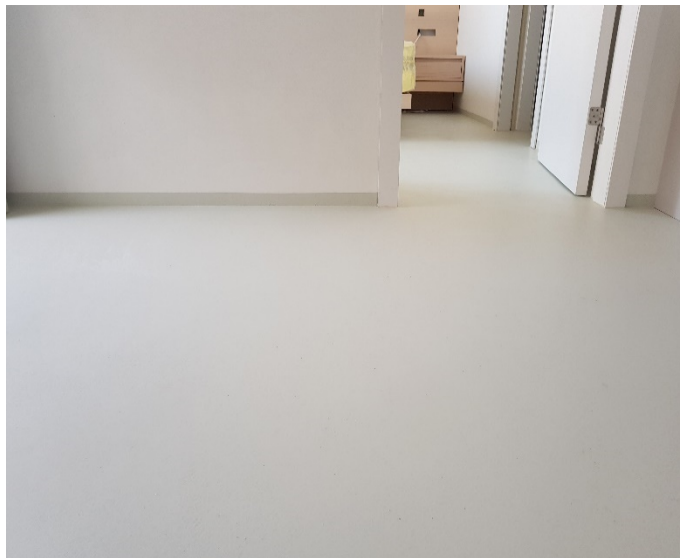
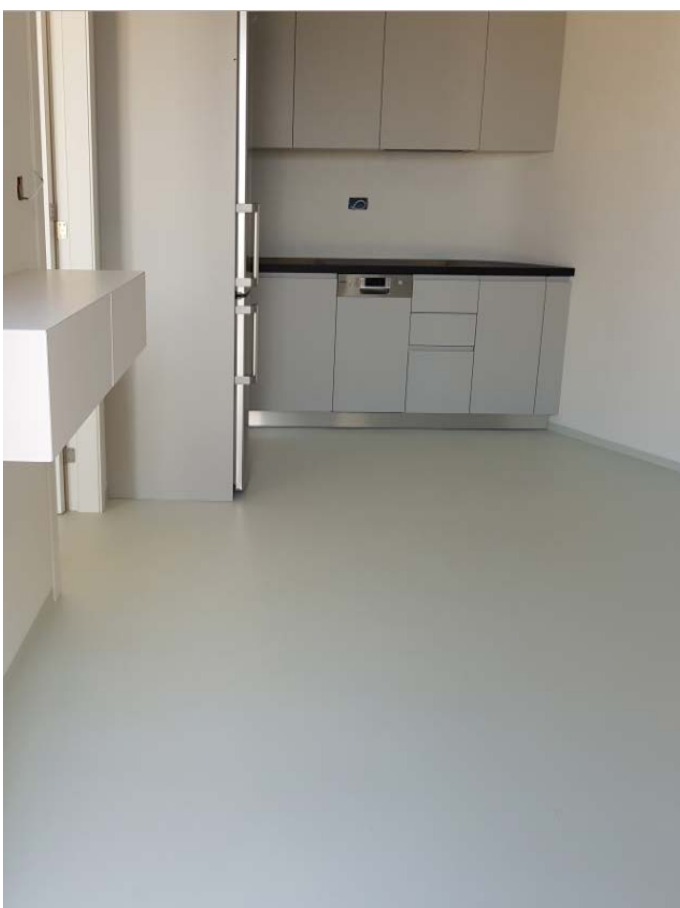
Wall & floor coating: On walls & floors **Sikafloor®-305 W** coating was applied, which creates a uniform aesthetic appearance in the area, contributing to the sense of uniform aesthetic in the house atmosphere, harmonizing with the external environment. The great ease of application, combined with its high mechanical characteristics and ease of cleaning made it the top choice for the villa.

Wall & floor coating: For the walls & floors the polyurethane coating **Sikafloor®-305 W** was used, which features great easiness in cleaning, while exhibits exceptional resistance against yellowing and UV radiation.
