REFURBISHMENT CONCRETE REPAIR AND PROTECTION OF CHIMNEYS AND COOLING TOWERS

SUSTAINABLE REFURBISHMENT OF COOLING TOWERS

KEY STAGES IN THE CONCRETE REFURBISHMENT PROCESS

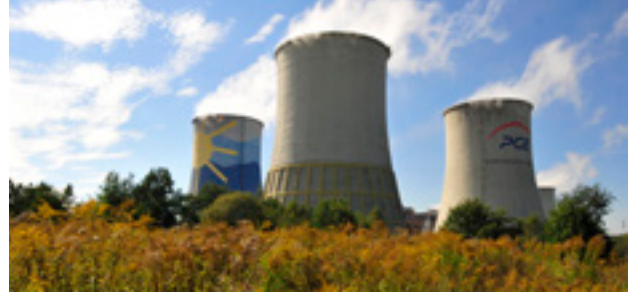
Natural Draft Cooling Tower Refurbishment Scenarios 20'000 m²

Scenario 1 Cost orientated	Scenario 2 Retrofitting with durable system	Scenario 3 Durability orientated
Initial construction	No protection	No protection	Full protection with proven coating and adequate surface preparation
After 20 years	Full refurbishment Inadequate surface preparation highly solvented coatings	Full refurbishment proper surface preparation proven protective coatings	Refreshing coat only
Every 10 years	Full refurbishment as after 20 years	No requirement	No requirement
Every 20 years		Refreshing coat only	Refreshing coat only

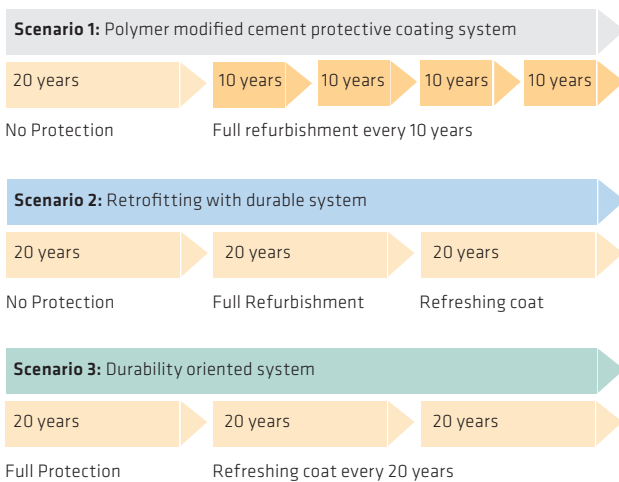
Advantages of scenario 3 over scenario 2 is the better flexibility for correct application of the protection system at the time when the tower is erected.

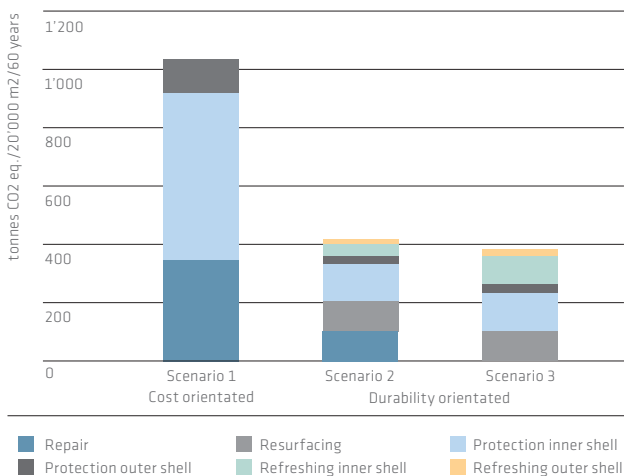
Global Warming Potential (GWP)

The greater resource efficiency of **scenario 2 and 3** allows saving of 600 tons of CO₂ over the life cycle of 60 years.

➔ This is equivalent to a saving of 77'000 km a year (compared to the limit of the European Union of not more than 130 g of CO₂ per km targeted for 2015).

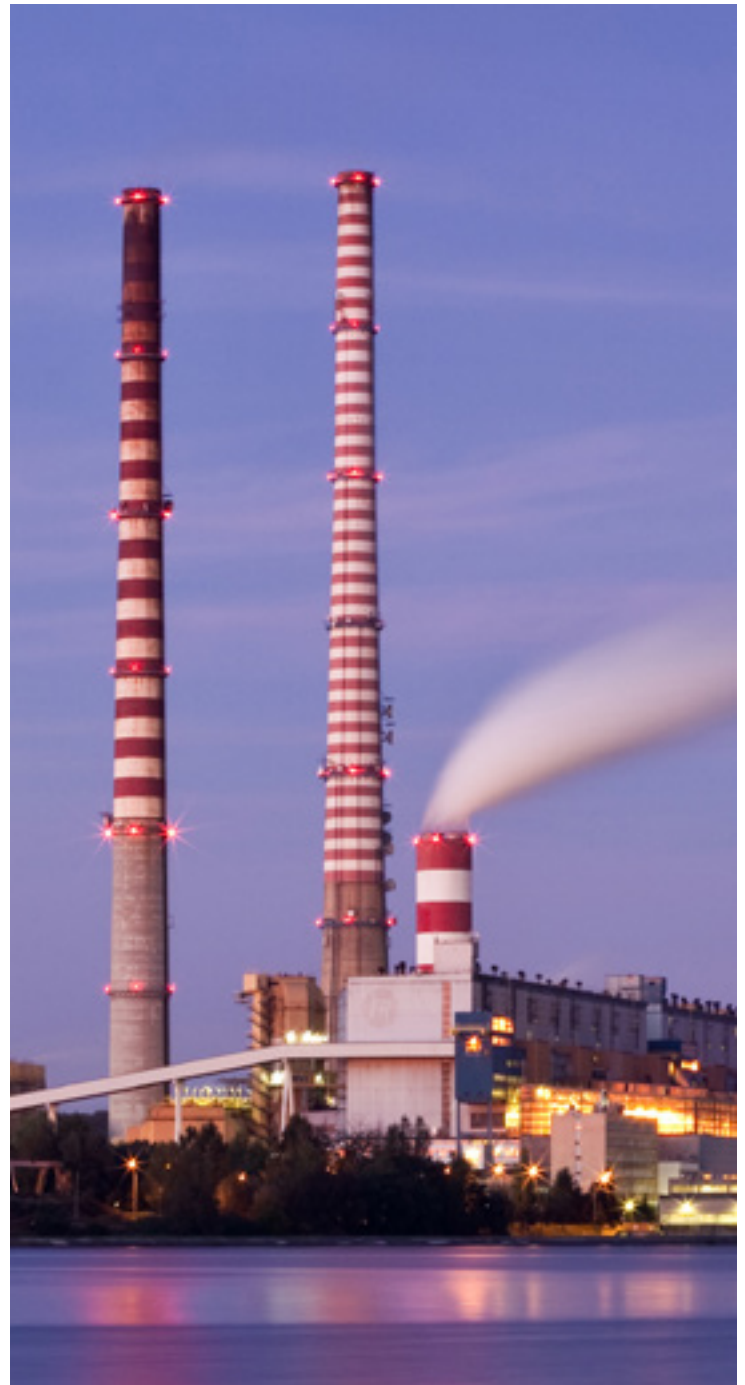
The exposed external surfaces of chimneys are normally subdivided into zones, according to their level of exposure to these gases and other potentially damaging influences.

- General industrial area atmosphere
- Rain and weathering (possibly limited by other structures – can accelerate carbonation)

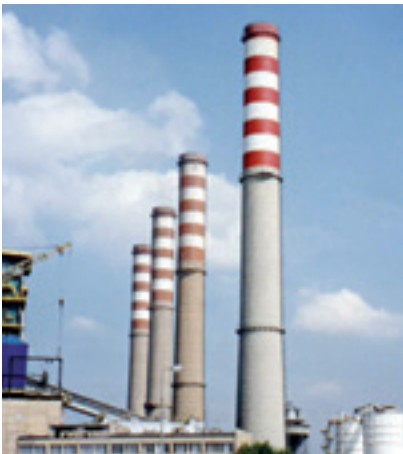
Note: With adjacent chimneys Zone 1 and Zone 2 of the surface both become larger.

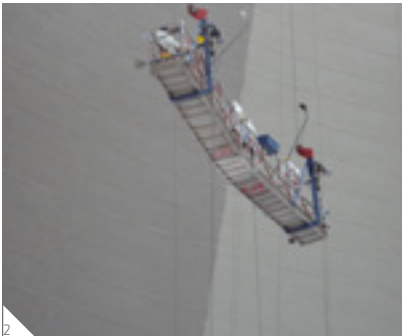
1 Severe combined exposure of multiple adjacent cooling towers and chimneys at power stations and industrial complexes.

2 Specialist equipment and materials are required for all of the internal works in these structures.

3 Severe internal exposure to aggressive gases and chemicals aggravated by direct UV light exposure and thermal variations at the top.

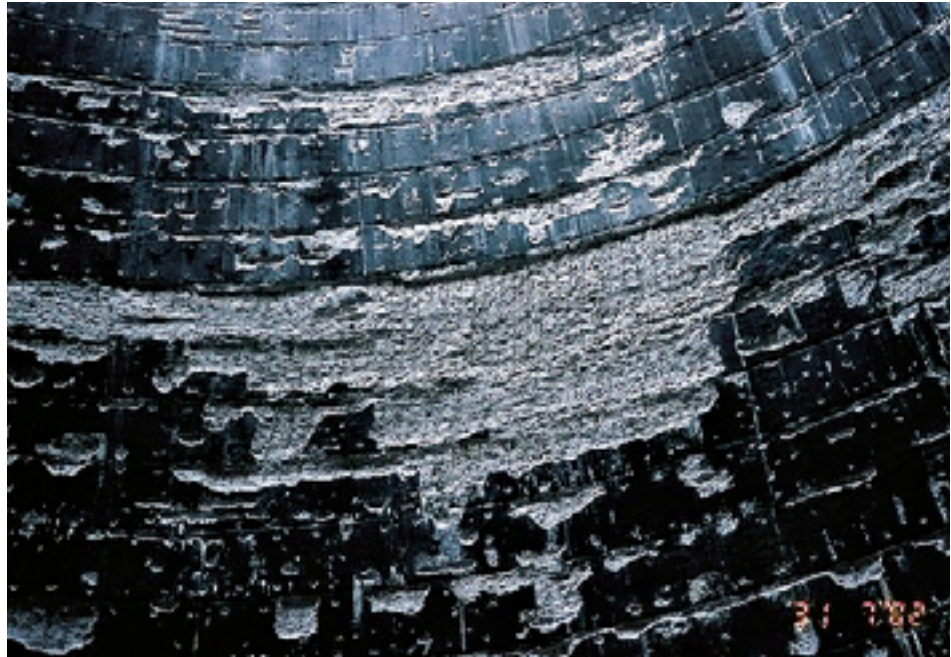
Severe corrosion of concrete and then of the steel reinforcement internally, despite a previously applied coating (coating was inadequate).

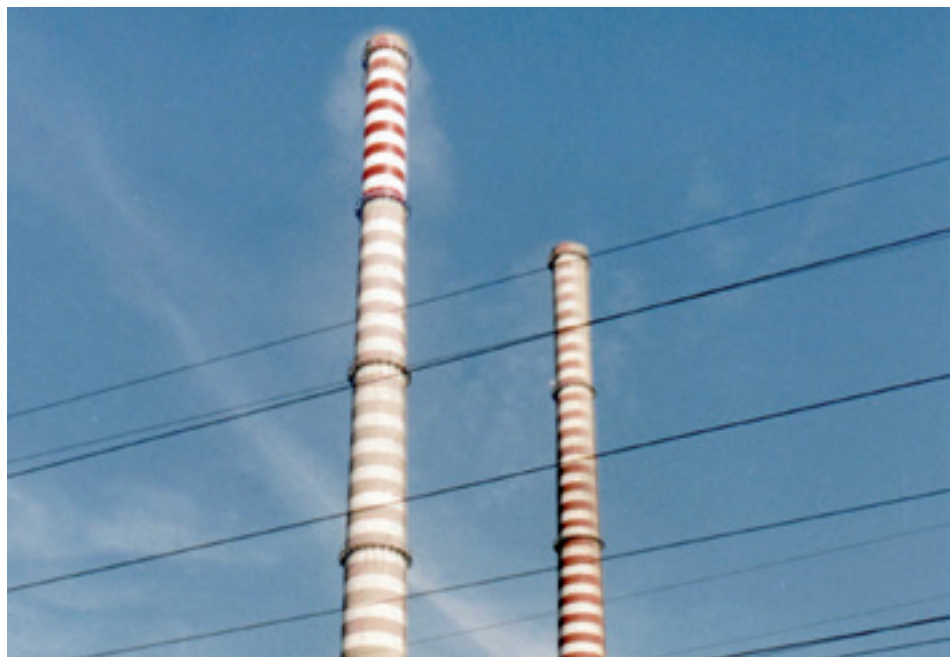
Chimneys in direct sunlight indicating variations in thermal exposure which are further exacerbated by the effects of the downward flow of hot exhaust gases during periods of temperature inversions.

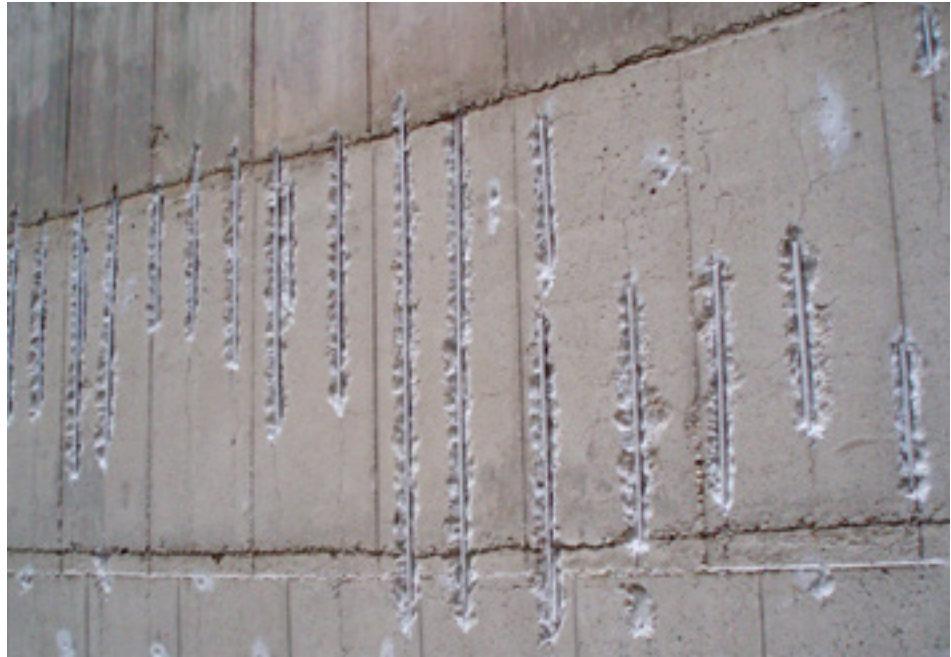
General corrosion induced by carbonation aggravated with low concrete cover issue.

Carbon dioxide from the atmosphere penetrates progressively into the concrete and reacts with the calcium hydroxide in the pore liquid. This eventually reduces the protective alkalinity around the steel, allowing corrosion to start in presence of water. This phenomenon is often associated with low concrete cover.

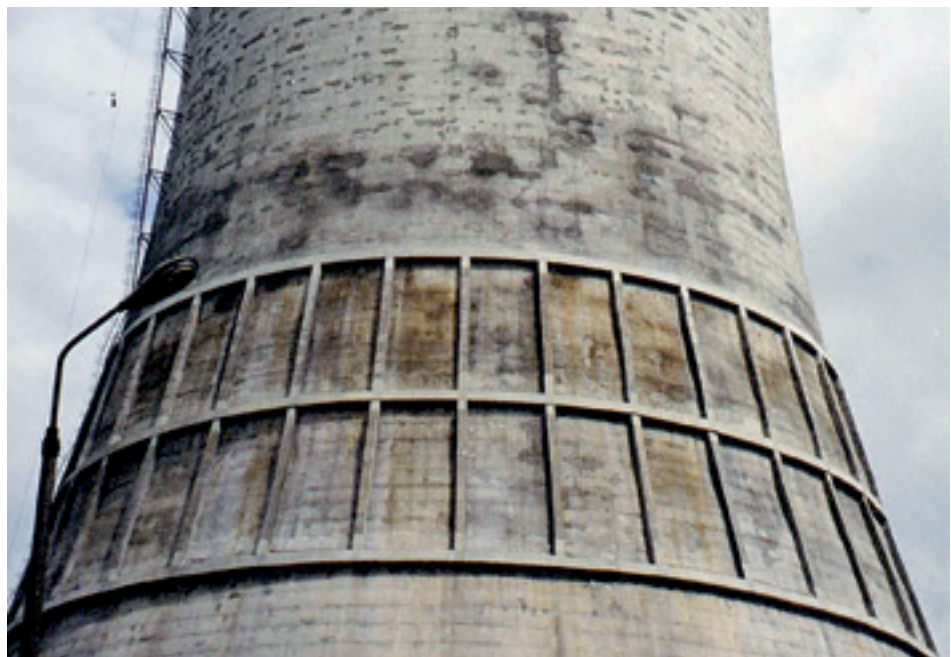
Carbonated concrete with spalling over corroded reinforcement accelerated by the steel being attacked by the acidic exhaust gases.

In these structures corrosion of the reinforcement can also occur due to attack from chlorides in marine atmosphere. However, the steel is far more frequently attacked directly by the acidic exhaust gases in conjunction with carbonation of the surrounding concrete. This means that the steel corrosion is accelerated and spalling, plus erosion increases.

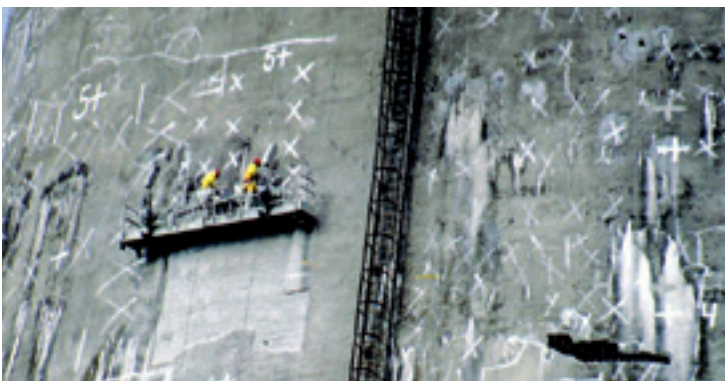
Break-out and removal of damaged concrete areas marked for repair in the condition survey.

As a general rule concrete removal should be kept to a minimum, particularly any sound concrete. However, where actively corroding steel reinforcement is present, it must be fully exposed to beyond its corroding length and around its full circumference. To allow cleaning and preparation, a distance equivalent to the bar diameter and a minimum of 12.5 mm is normally required.

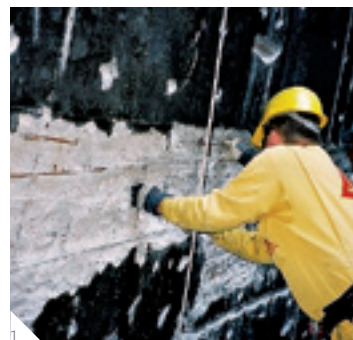
- 1 Removal of damaged concrete from inside a cooling tower.
- 2 Concrete removal behind the steel bars to ensure room for corrosion protection to be applied.
- 3 Corroding steel exposed after concrete removal.

Any exposed steel reinforcement should be cleaned to remove rust and corrosion products. EN 1504 Part 10 recommends the steel be prepared to Sa 2 1/2 (if barrier coating is applied) or to Sa 2 (if active coating is applied). These denominations are originally from a Swedish Standard but now adapted into an international standard ISO 8501-1.

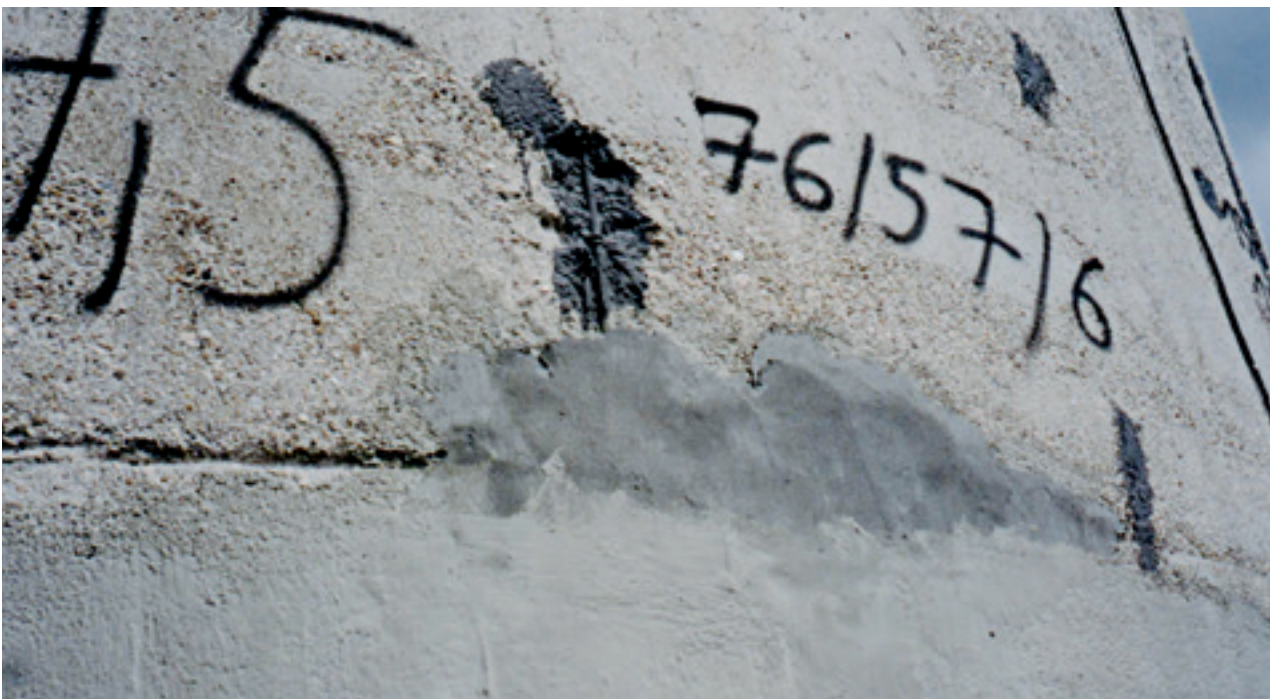
Steel reinforcement prepared and protected with Sika MonoTop®-910 ready for repair mortar application.

SikaTop® Armatec®-110 EpoCem® for use in highly corrosive environments with all Sika repair systems, where it provides an excellent barrier to chloride ion diffusion and penetration. The coating must be applied around the full circumference of the steel bars and to beyond the areas that were corroding and wherever there is inadequate or insufficient concrete cover.

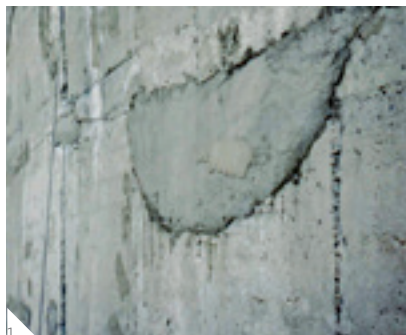
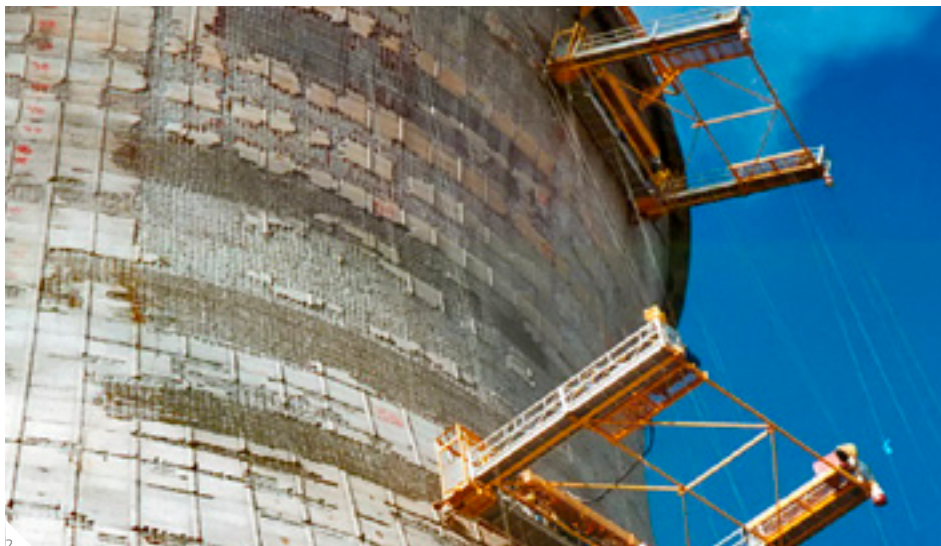
1 Hand applied Sika MonoTop® repair mortar.

2 Typical large damages to be repaired using dry spray technique.

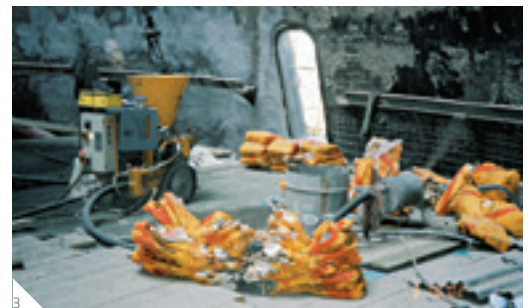
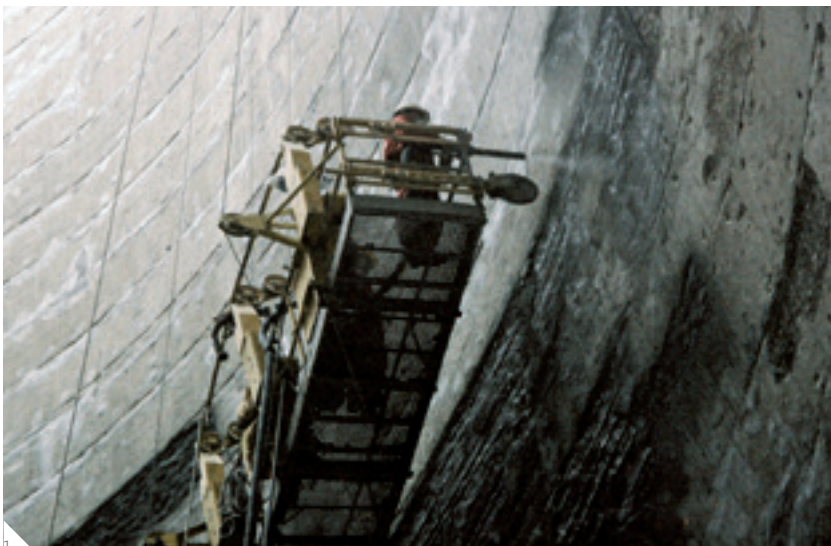
- 1 Internal application of Sika spray applied repair mortars in a cooling tower refurbishment.
- 2 Difficult shaped support structures easily repaired with SikaCem® Gunitite 133.
- 3 Sika Aliva dry spray equipment in operation applying SikaCem® Gunitite 133 inside a cooling tower.

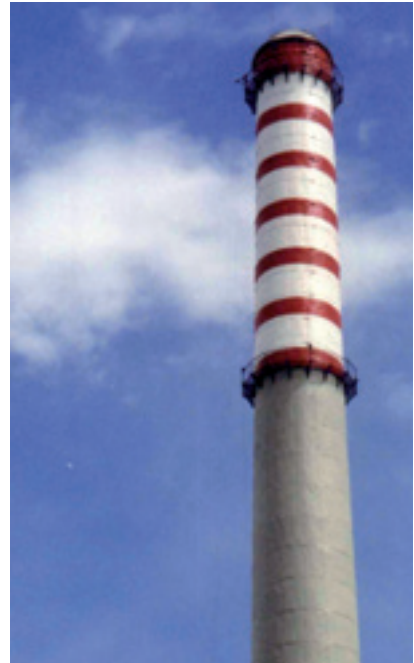
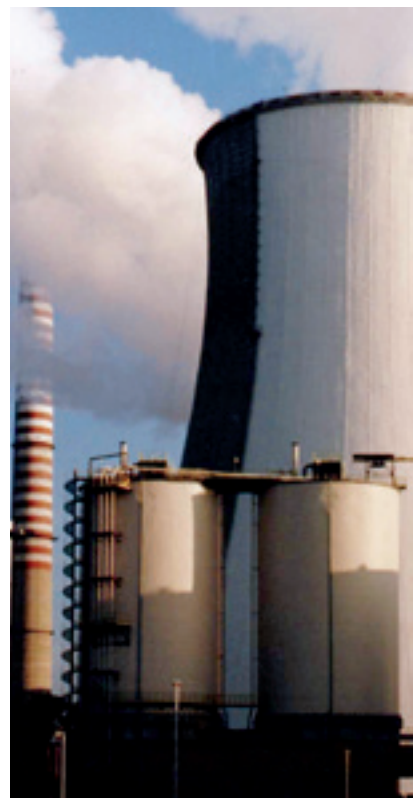
Aircraft warning colors using SikaCor® EG 5 as the top coating in zone 1 of a concrete chimney refurbishment.

Sika protective coatings being applied to the external surfaces (all zones) of a cooling tower.

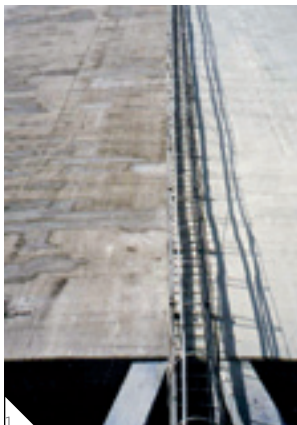
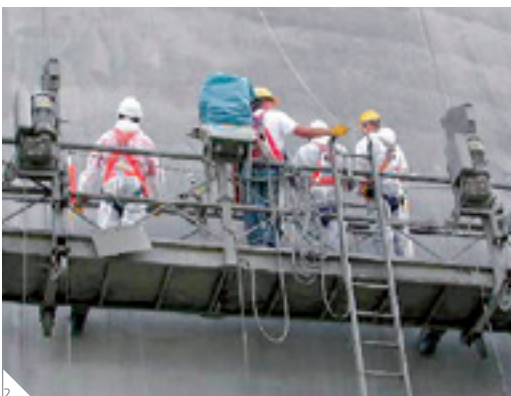
- 1 Locally repaired surface ready for levelling on the left and afterwards on the right.
- 2 Application of Sika MonoTop®-620 levelling mortar onto the patch-repaired concrete surface prior to coating.
- 3 The concrete surface without pore filling and levelling but treated with hydrophobic primer (zone 2 and 3).

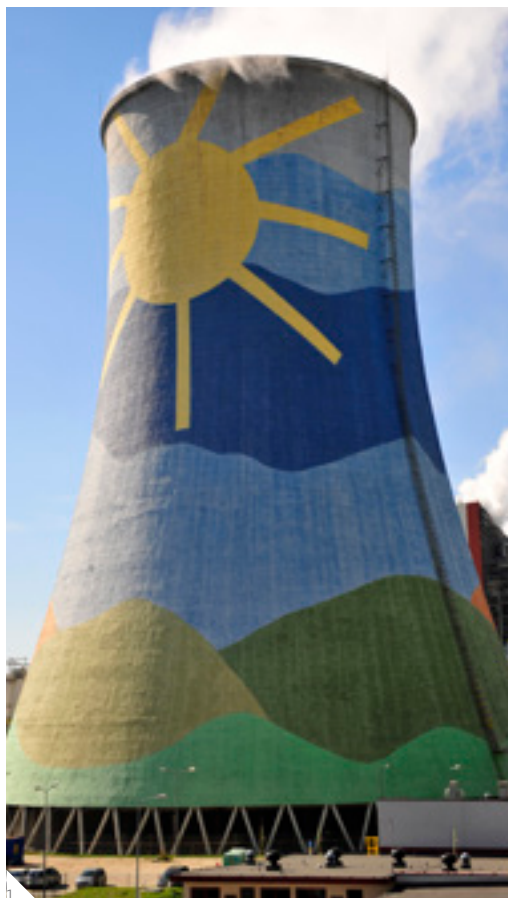
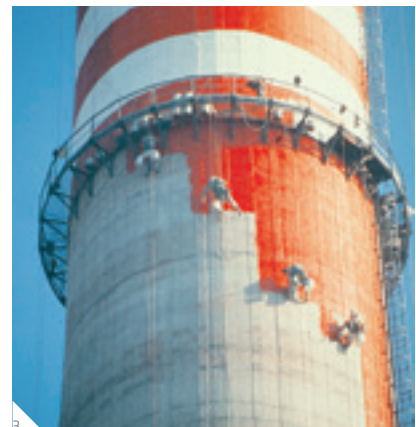
- 1 Creative designs are also possible with Sikagard® protective coatings.
- 2 External coatings can be exposed to exhaust gases from adjacent chimneys
- 3 Abseiling specialists applying Sikagard®-680 S.

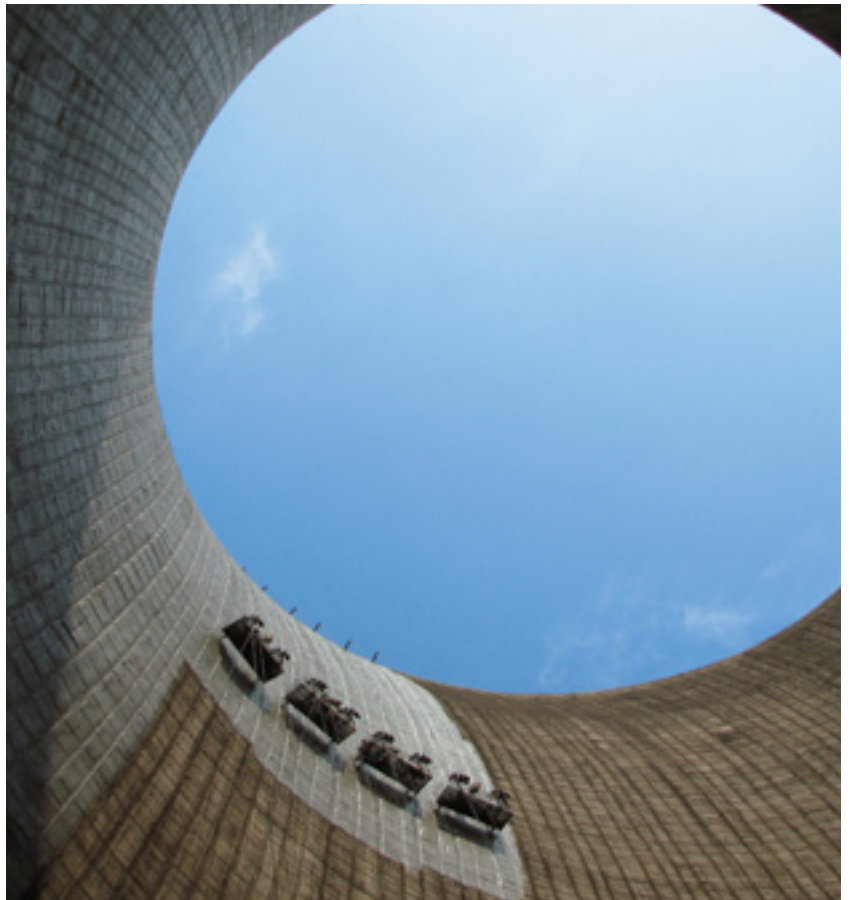
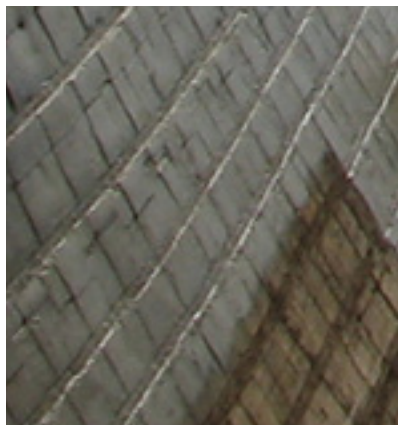
Application of the Sika Icosit®-2406 protective coating system from specialist powered access cradles.

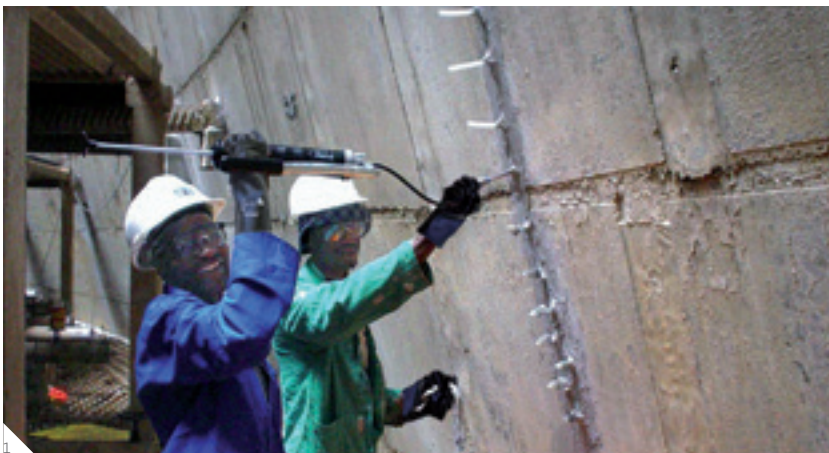
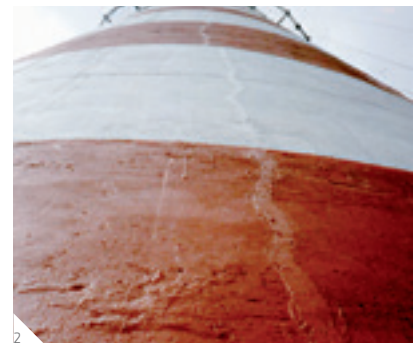
1 Structural bonding of cracks to restore structural integrity with Sika® Injection resin.
2 Crack-sealed with Sikaflex sealant and overcoated with Sikagard®-680 S protective coating.

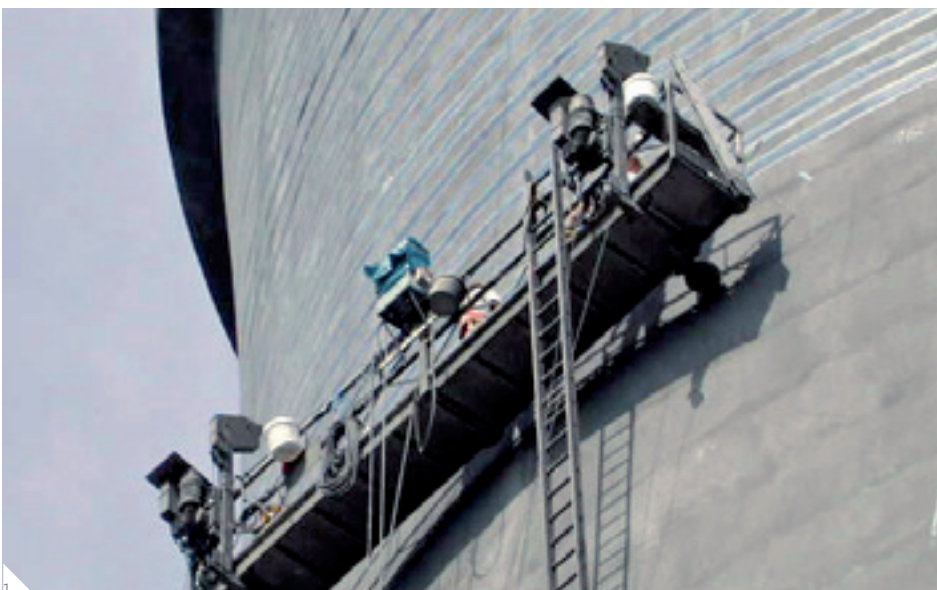
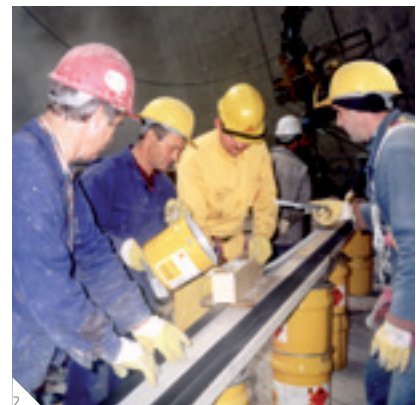
- 1 Sika CarboDur® CFRP plates being bonded with Sikadur® epoxy adhesive directly to the repaired external concrete surface at the top of a cooling tower for increased restraint.
- 2 Sikadur® adhesive application to the Sika CarboDur® plate.
- 3 Easy application of the Sika CarboDur® plates from powered access cradles.

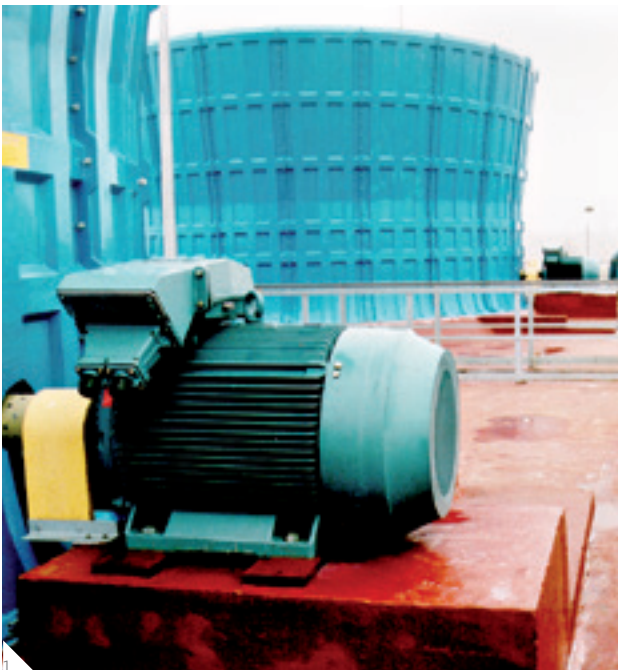
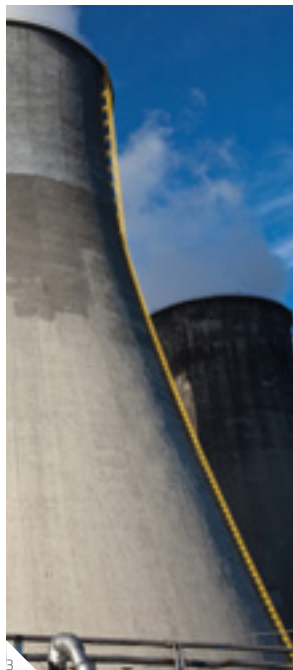
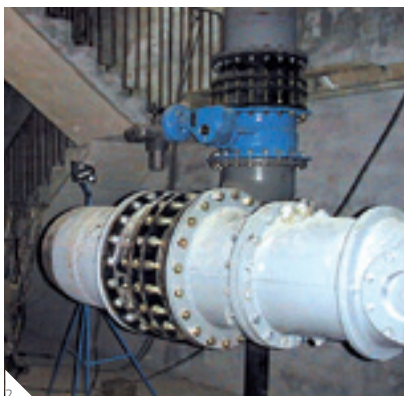
- 1 SikaCor® steel coatings and Sikafloor® concrete protection applied to ancillary equipment and surfaces.
- 2 Associated equipment protected with SikaCor® steel coatings for durable corrosion protection.
- 3 Galvanized steel ladders protected with direct application SikaCor® coatings.

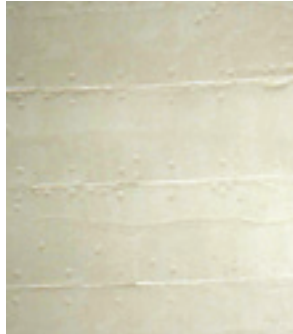
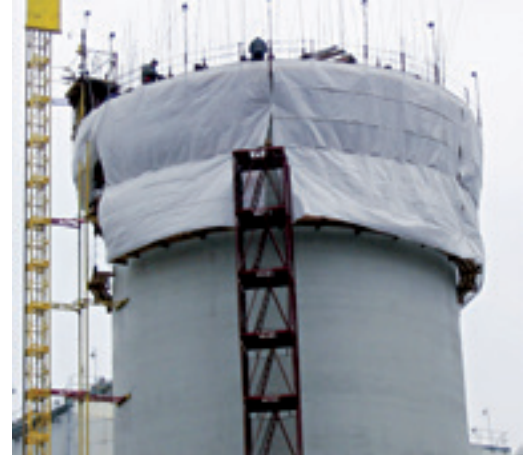
Sika Icosit®-2406 epoxy coating applied inside a cooling tower.

Right: Slip-forming a new concrete chimney base structure with Sika® ViscoCrete® technology.

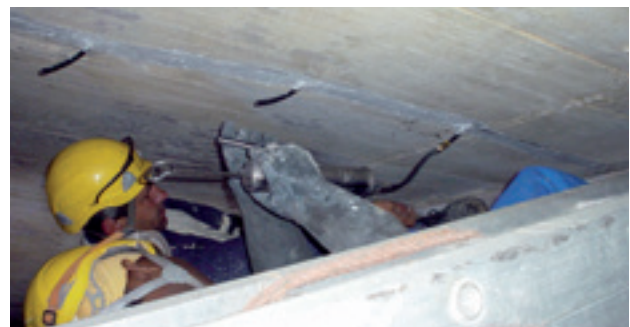
Crack Injection.
