REFURBISHMENT SIKA TECHNOLOGIES AND SOLUTIONS FOR WASTE WATER TREATMENT PLANTS

SUSTAINABLE REFURBISHMENT OF WASTE WATER TREATMENT PLANTS

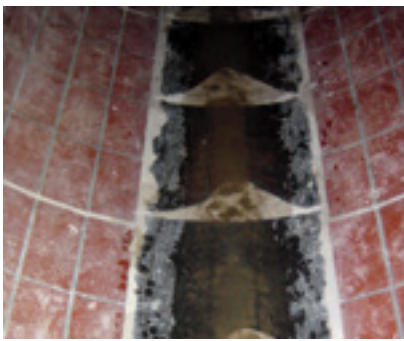
1 Damages at the bottom:

Heavy abrasion and erosion of the concrete and prefabricated elements are often found at the bottom of the sewers.

In general rules, these elements shall be replaced and reassembled properly by bonding them in place with an epoxy adhesive.

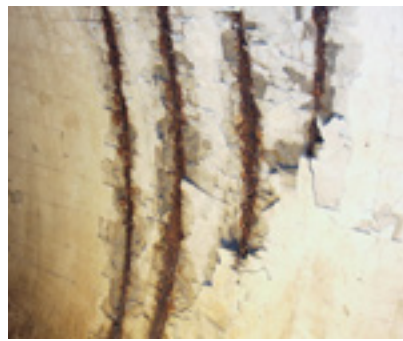
2 Localized defects of the concrete:

Lateral walls and the crown often show localized defects of the concrete and sometimes defects due to the corrosion of the reinforcement. After appropriate preparation, these defects can be repaired using sulfate resistant repair mortars.

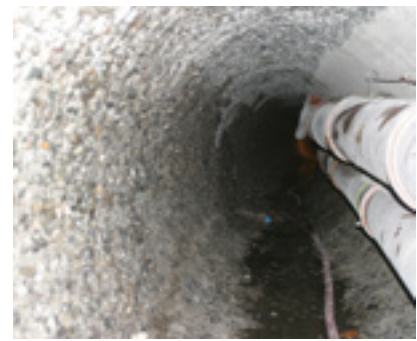
3 Full degradation of the concrete surface:

The resistance of tamped concrete against a strong water current is generally not enough and often the full surface of the concrete is eroded. It is recommended in these zones to proceed with a full resurfacing.

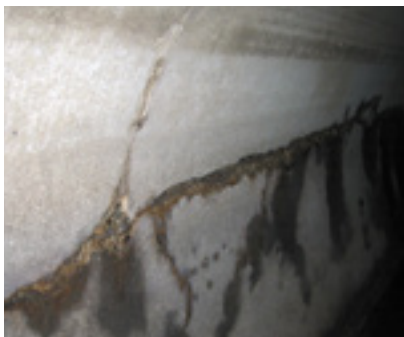
4 Cracks with water leaks:

Due to shrinkage or settlements, concrete in sewers often cracks. These cracks need to be filled in order to prevent leakage of pollutant to surrounding ground water. It is often necessary to use expanding materials to fill these cracks.

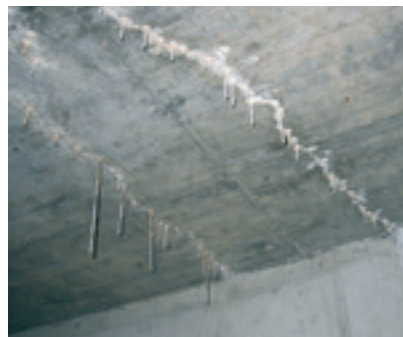
5 Damages at the crown:

Exposed tamped concrete surfaces show very low resistance against carbonation and the aggressive substances contained in the waste water. Therefore, these surfaces can be protected using EpoCem® technologies which are extremely resis-

tant and watertight against urban waste water.

At the crown area, the structure can be protected against condensation water using a hydrophobic impregnation.

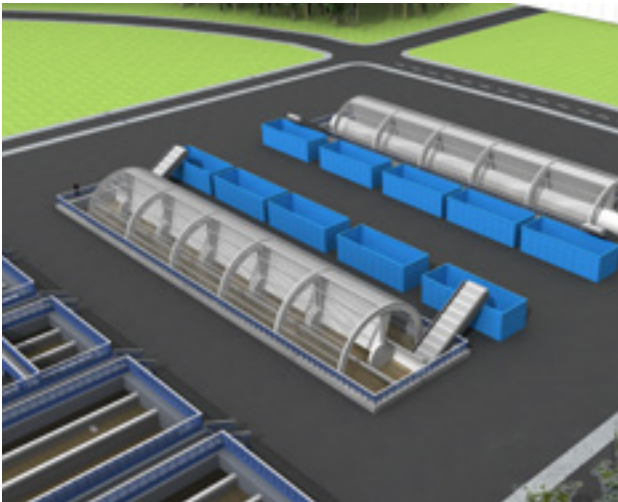
SCREENING CHANNELS

- Abrasion and erosion due to sand, grit or other heavy particles
- Chemical attacks due to aggressive waste or industrial water
- Leakage due to cracks, untight joints or damaged concrete

- Abrasion and erosion:
Sika® Abraroc® SR
- Chemical attacks:
Sikagard®-720 EpoCem® + Sika® Poxitar F (or Sikagard®-63 N)
- Cracks, untight joints:
Sikadur-Combiflex® SG or Sikaflex® Pro-3

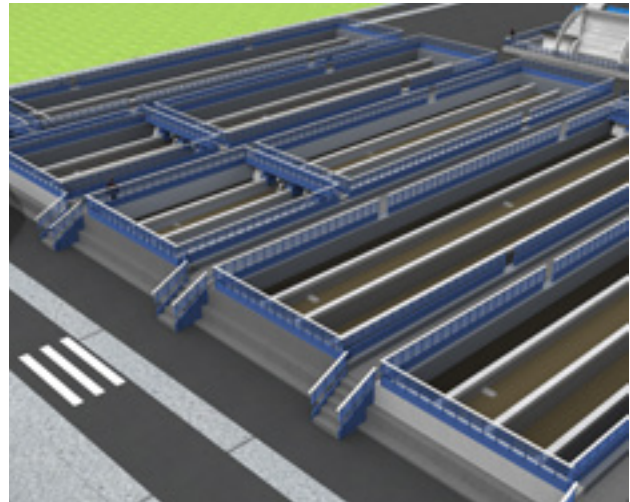
GRIT, FAT & GREASE CHAMBERS

- Abrasion and erosion due to sand, grit or other heavy particles
- Chemical attacks due to aggressive waste or industrial water
- Leakage due to cracks, untight joints or damaged concrete

- Abrasion and erosion:
Sika® Abraroc® SR
- Chemical attacks:
Sikagard®-720 EpoCem® + Sika® Poxitar F (or Sikagard®-63 N)
- Cracks, untight joints:
Sikadur-Combiflex® SG or Sikaflex® Pro-3

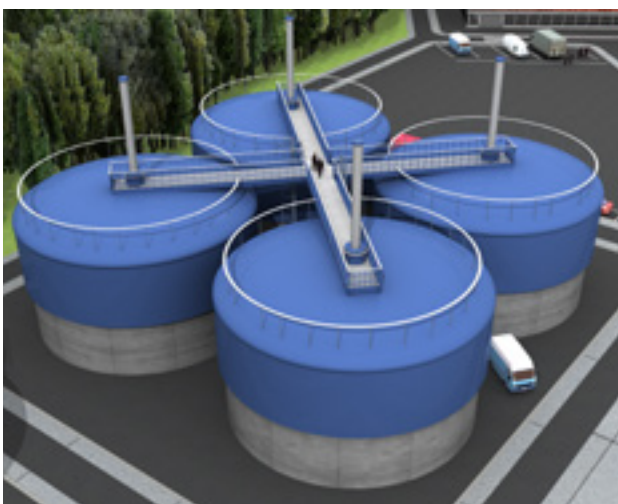
GASOMETERS

- Steel corrosion
- Untight joints
- Sulfuric acid damages

- Steel corrosion:
Sika® Icosit® 6630 System or SikaCor® EG System
- Steel joint:
Sikaflex® TS Plus
- Sulfuric acid attack:
Sika® Permacor® 3326 EG H or Sikalastic®-844 XT

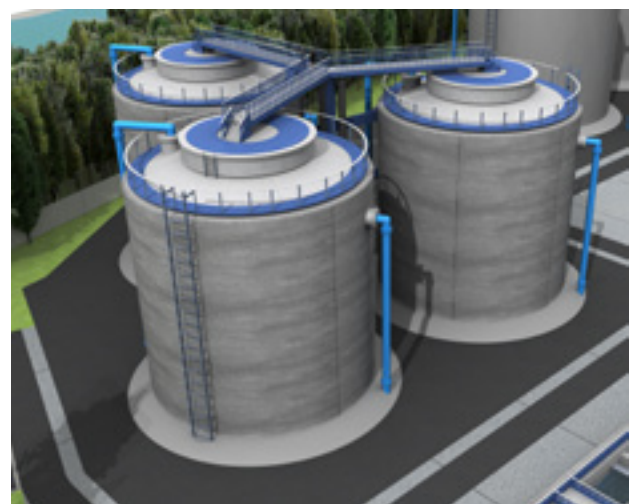
DIGESTION TANKS

- Concrete damage due to sulfuric acid
- Leakage due to damaged waterproofing
- Cracks due to thermal expansion or shrinkage

- Sulfuric acid attack and waterproofing:
Sika® Permacor® 3326 EG H
or Sikalastic®-844 XT
- Cracks:
Sikadur-Combiflex® SG
- Chemical resistant joint:
Sikaflex® Pro-3

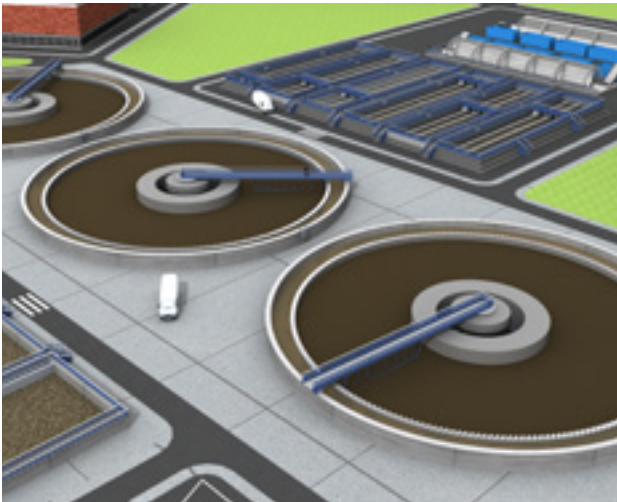
PRIMARY SEDIMENTATION TANKS

- Chemical attacks due to aggressive waste or industrial water
- Leakage due to improper waterproofing
- Cracks due to thermal expansion or shrinkage
- Steel reinforcement corrosion due to low concrete cover
- Mechanical abrasion at the rolling pad

- Chemical attacks and damaged waterproofing:
Sikagard®-720 EpoCem® + Sika® Poxitar F (or Sikagard®-63 N)
- Cracks, untight joints:
Sikadur-Combiflex® SG or Sikaflex® Pro-3
- Damaged concrete and steel reinforcement corrosion:
Sika MonoTop®-412 NFG, SikaTop® Armatec®-110 EpoCem®
- Mechanical abrasion:
Sikadur®-42 or Sika® Icosit®-KC 330 FK

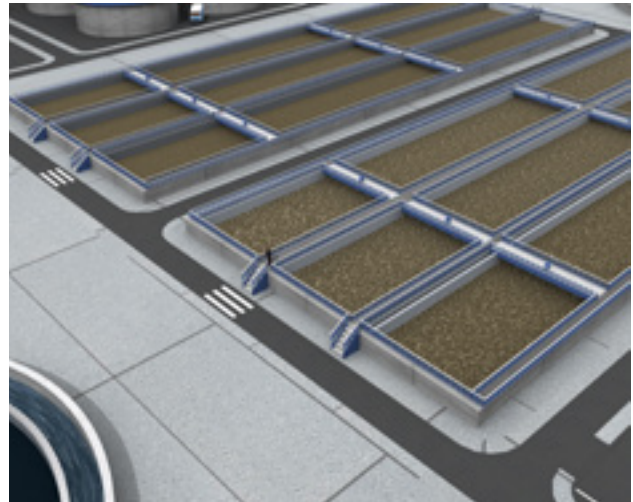
BIOLOGICAL TANKS

- Erosion due to water flow
- Chemical attacks due to aggressive waste or industrial water
- Leakage due to damaged waterproofing
- Cracks due to thermal expansion or shrinkage
- Steel reinforcement corrosion due to low concrete cover

- Chemical attacks and damaged waterproofing:
Sikagard®-720 EpoCem® + Sika® Poxitar F (or Sikagard®-63 N)
- Cracks, untight joints:
Sikadur-Combiflex® SG or Sikaflex® Pro-3
- Damaged concrete and steel reinforcement corrosion:
Sika MonoTop®-412 NFG, SikaTop® Armatec®-110 EpoCem®

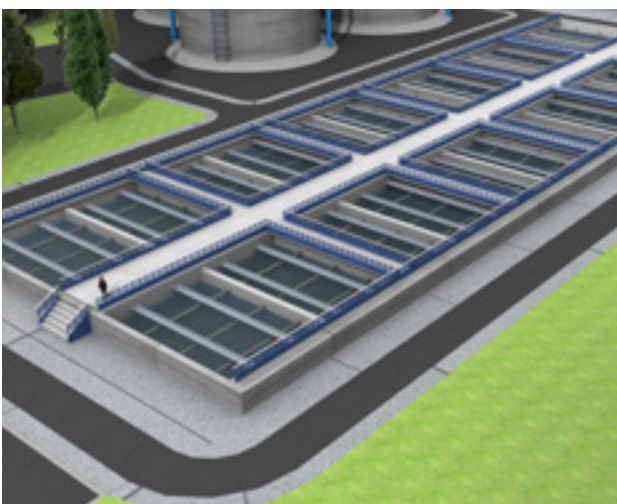
FILTRATION BEDS

- Abrasion due to sand
- Leakage due to damaged waterproofing
- Cracks due to thermal expansion or shrinkage

- Abrasion:
Sika® Abraroc® SR
- Damaged waterproofing:
Sikagard®-720 EpoCem®
- Cracks:
Sikadur-Combiflex® SG or Sikaflex® Pro-3

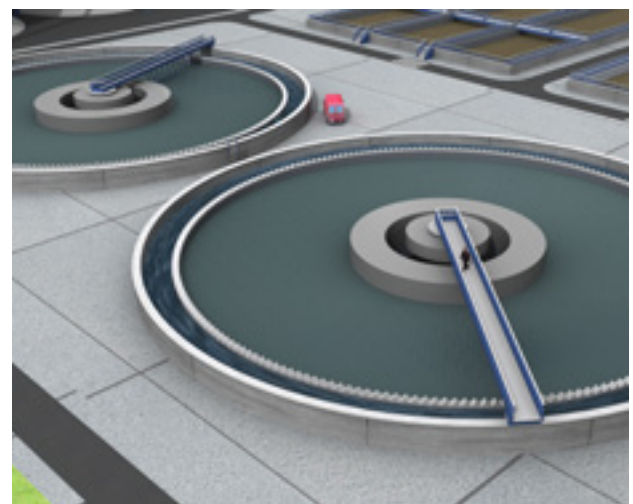
SECONDARY SEDIMENTATION TANKS

- Leakage due to damaged waterproofing
- Cracks due to thermal expansion or shrinkage
- Mechanical abrasion at the rolling pad

- Damaged waterproofing:
Sikagard®-720 EpoCem®
- Cracks:
Sikadur-Combiflex® SG or Sikaflex® Pro-3

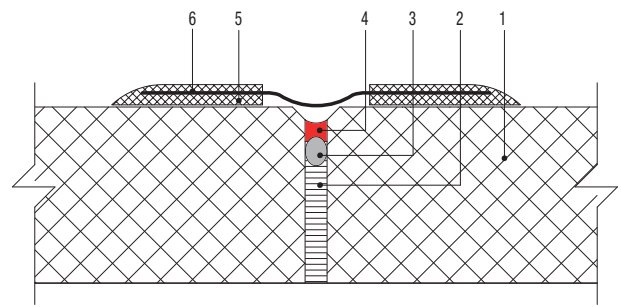
TYPICAL DETAIL

Very often in waste water treatment, joints sealed with average sealant fail due to the lack of chemical resistance of these products. Instead of proceeding to the full removal of the failed joint, Sika has developed joint system that can be applied over the original failed material.

| 1 Substrate | 4 Failed sealant |

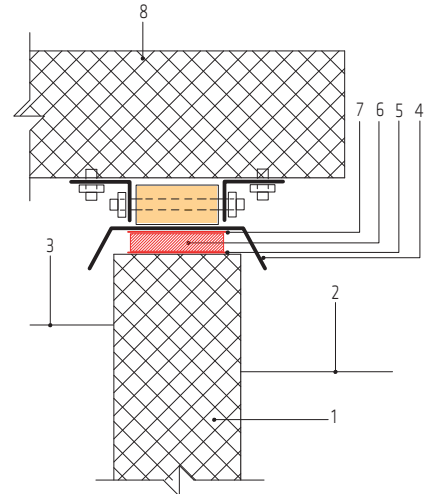
TYPICAL DETAIL

- 1 Concrete wall of clarifier
- 2 Ground level
- 3 Water level within the clarifier
- 4 V2A Stainless steel plate
- 5 Priming of concrete surface with Primer such as Sika® Icosit® KC 330 Primer or equivalent
- 6 Shock absorbing, vibration damping & bonding material such as Sika® Icosit® KC 330 FK
- 7 Priming after grinding the under side of the stainless steel plate with primer such as Sika® Icosit® KC Primer or equivalent
- 8 Scraper bridge

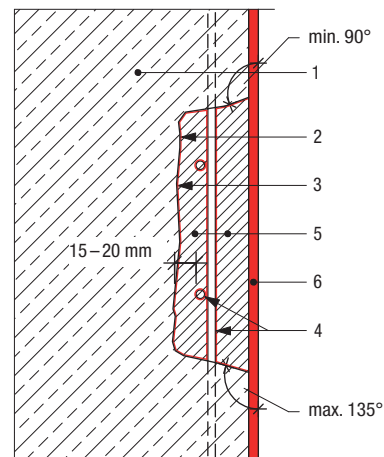
TYPICAL DETAIL

- 1 Host sound concrete
- 2 Cutting line of damaged concrete, cleaned and prepared substrate
- 3 Bonding primer (if relevant/required: e.g. SikaTop® Armatec®-110 EpoCem®)
- 4 Corrosion protective coat (e.g. SikaTop® Armatec®-110 EpoCem®)
- 5 Repair mortar (e.g. Sika MonoTop®-412 NFG)
- 6 Smoothing coat (e.g. Sika MonoTop®-723 N)

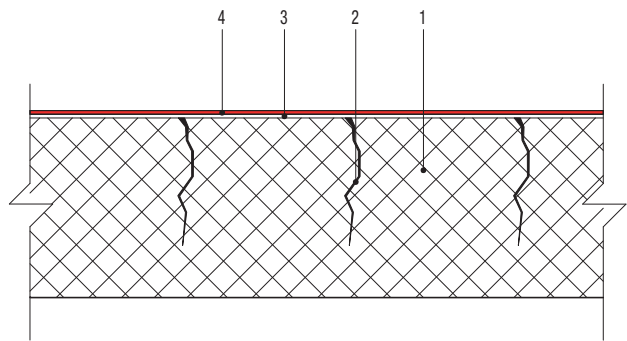
TYPICAL DETAIL

- 1 Concrete
- 2 Cracks
- 3 Primer Sikafloor®-156/-161 lightly broadcasted with quartz sand 0.3 - 0.8 mm
- 4 1 x Sikalastic®-844 XT

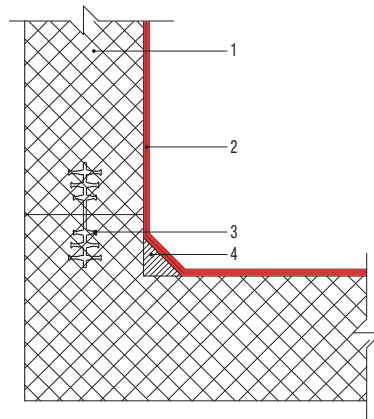
- 1 Concrete substrate
- 2 Sikagard®-720 EpoCem®
- 3 Construction joint Sika® Waterbar
- 4 Sika MonoTop®-412 N

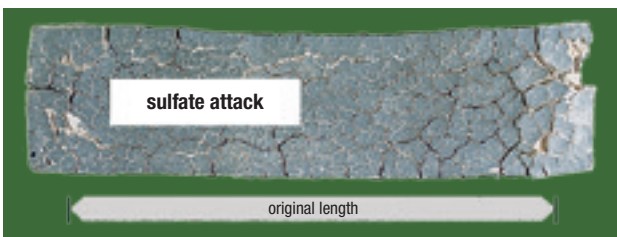
Sulfate driven attack is primarily caused by sulfates dissolved in water. By reacting with the hardened cement matrix, an increase in volume is induced, which damages the structure. (Picture: BetonSuisse, Merkblatt 01)

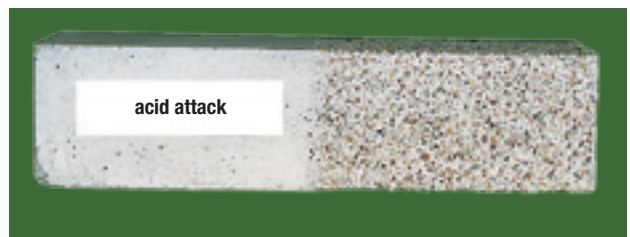
Acidic attacks which dissolve calcium compounds out of the hardened cement matrix can be caused by acids, exchangeable salts, vegetable and animal fats or oils. Degradation of the concrete usually occurs very slowly. (Picture: BetonSuisse, Merkblatt 01)
