Restoration of Panourgia's house and transformation into Historical Information Centre, Amfissa, Greece

TEXTILE REINFORCED MORTAR SYSTEM (TRM): Sika MonoTop®-722 Mur, SikaWrap®-350 G Grid, SikaWrap® FX-50 C, Sikadur®-52 LP, Sika® AnchorFix®-3+

RESTORATION OF PANOURGIA'S HOUSE, GREECE

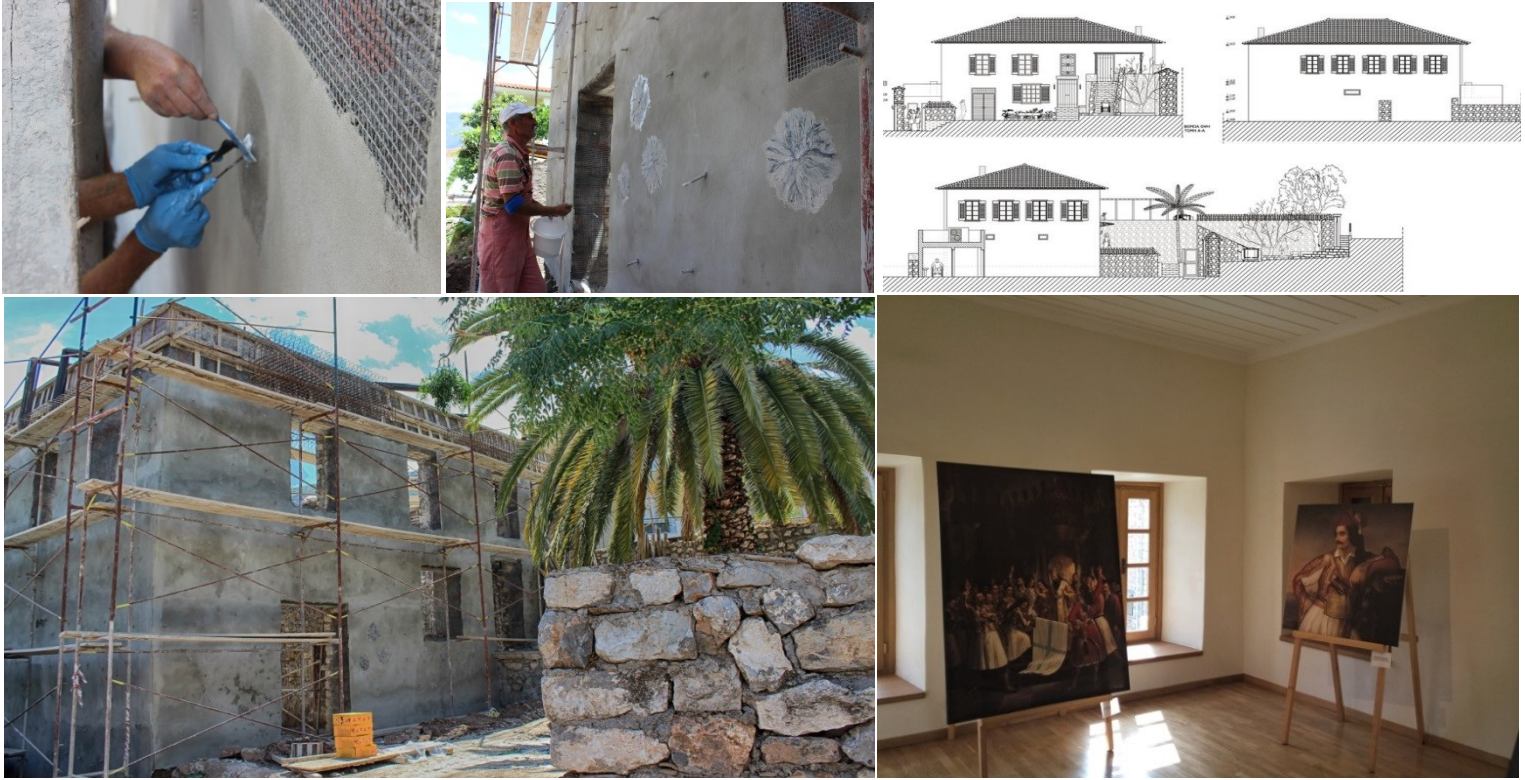
All remediation requirements were satisfied with the integration of the current needs in the traditional shell via strengthening the bearing structure (inorganic matrix method - in Greece has been implemented in a few structures and on a much smaller scale). The same materials from the area of the construction were used, so as to achieve full harmonization of the building with its natural environment and involve as much as possible the wisdom and truth of the original construction. The integrated Textile Reinforced Mortar System (TRM) of Sika gave new life to the building, serving the needs of the most compatible possible intervention in the bearing structure.

Sika system comprises of the 1-component mortar **Sika MonoTop®-722 Mur**, with especially good workability and thixotropy, according to EN 998-1 (GP) and EN 998-2 (M20) for masonry applications. The special glass, alkali resistant mesh **SikaWrap®-350 G Grid**, with high tensile strength in both directions is embedded in the mortar. The special carbon fiber cordons **SikaWrap® FX-50 C** are used to anchor the system to the substrate. The specification made provisions for a double layer system at the bottom (ground floor) and single at the upper floor (1st floor). Also, the injection resin Sikadur® -52 LP and the anchoring resin Sika® Anchorfix-3+ were used.
