STRENGTHENING SikaWrap® FX

CARBON FIBER STRINGS FOR STRUCTURAL STRENGTHENING APPLICATIONS

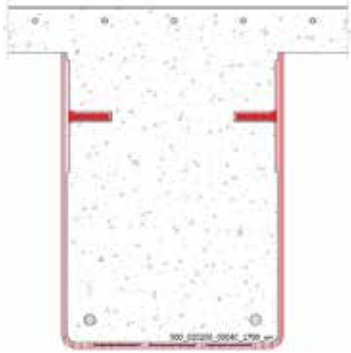
<p>1. SikaWrap® FX FOR THE ANCHORAGE OF SikaWrap® FABRIC SYSTEMS</p> <p>With SikaWrap® carbon fiber fabric applied for shear strengthening, the weakest points are always the fabric ends. During any overload, these ends of the fabric may start to peel and thereby reduce the overall strength of the member significantly.</p> <p>In order to avoid this, SikaWrap® FX strings can be used to create an embedded end-anchor, with one part bonded into holes predrilled in the substrate and the other part spread out into slots cut in the concrete surface. In this way the substrate and the structural connection are both strengthened, whilst also significantly increasing the peel-resistance of the system.</p>

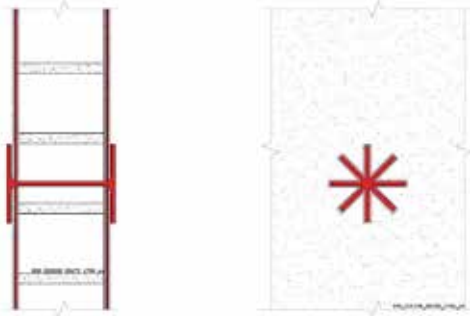
<p>2. SikaWrap® FX AS A THROUGH-ANCHOR FOR THE SIKATEXILE REINFORCED MORTAR SYSTEM (TRM)</p> <p>The Sika TRM system is based on cementitious mortar and bonds well to both hollow and solid masonry structures. In some cases, additional anchorage of this system is required and SikaWrap® FX can easily be installed through masonry walls and spread out on both sides, then bonded into or onto the mortar system as required. The Sika TRM system is then even more securely bonded to the substrate and an integral part of the masonry walls, meaning that any potential danger of de-bonding is significantly reduced.</p>

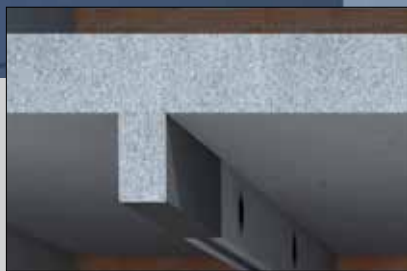
1

SikaWrap® FX for the anchorage of SikaWrap® fabric systems

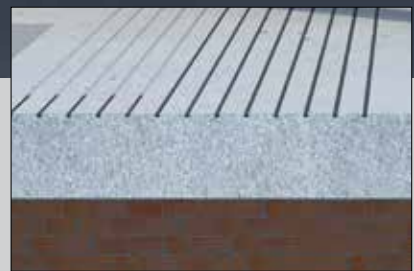
3

SikaWrap® FX for near surface mounted reinforcement (NSM)

<p>3. SikaWrap® FX FOR NEAR SURFACE MOUNTED REINFORCEMENT (NSM)</p> <p>Flexural strengthening for both negative and positive moments is usually done with Sika® CarboDur® CFRP plates, either applied externally, or as so-called NSM systems, installed in slots cut into the surface. As an alternative to these rigid plate profiles, SikaWrap® FX carbon fiber string system can also be used for such applications, and since they are impregnated with resin on-site, they have the additional advantages that they can be installed in any length and in any layout – including being curved, wrapped around any corners, or even in spirals, for example to strengthen reinforced concrete or masonry domes.</p>

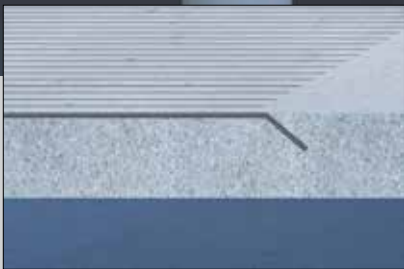
4

SikaWrap® FX for anchorage of near surface mounted (NSM) cantilevered applications

<p>4. SikaWrap® FX FOR ANCHORAGE OF NEAR SURFACE MOUNTED (NSM) CANTILEVERED APPLICATIONS</p> <p>Combinations of the anchorage and the NSM applications of SikaWrap® FX result in a useful cantilever strengthening system. This was originally developed to strengthen balcony decks, but it can also be used for many other different cantilever situations. With part of the SikaWrap® FX anchored into the main structure and the rest embedded in a slot on the balcony surface, these structures can take significantly more load.</p>

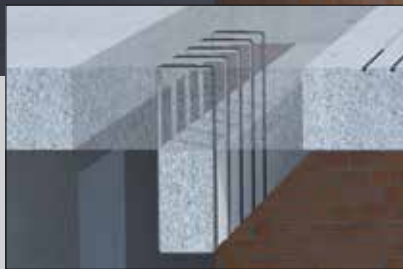
5

SikaWrap® FX for closed loop shear strengthening

<p>5. SikaWrap® FX FOR CLOSED LOOP SHEAR STRENGTHENING</p> <p>SikaWrap® FX can also be used as an alternative for the shear strengthening of beams instead of fully wrapping them with SikaWrap® carbon fiber fabrics. When using SikaWrap® FX systems this type of installation does not require the same extensive removal of damaged concrete, or the mechanical preparation of large surface areas, but only a few holes need to be drilled/cut to feed the SikaWrap® FX strings through. Where it is suitable this application is therefore cleaner, faster and easier for the same overall strengthening result.</p>

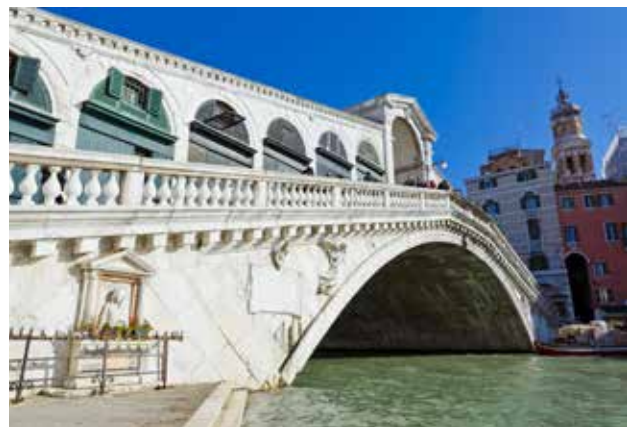
Ponte Rialto, Venice, Italy

Both sides of the Rialto Bridge are rimmed by a balustrade made of Istria stone, which protrudes beyond the external edge of the masonry arch and rests on stone cantilevers anchored underneath the deck. Upon close inspection and removal of the stone deck, many of these cantilevers supporting the balustrade turned out to be cracked and the balustrade had also rotated slightly outward. Therefore these needed their structural integrity to be restored and strengthened to ensure they could accommodate the loading for the long term.

Sika provided a complete integrated solution for all of the structural strengthening requirements using SikaWrap® fabrics to reinforce the stone cantilevers and increase the safety and support of the balustrades, thereby blocking any further rotation. This was achieved using SikaWrap® unidirectional carbon fiber fabric, impregnated with Sikadur® epoxy resin adhesive by careful manual dry application techniques. The connecting end-anchorage into the structure at each end, were formed with SikaWrap® FX carbon fiber strings, also impregnated onsite with Sikadur® epoxy resin and bonded into the stone supports with Sika AnchorFix®. The entire strengthening solution is also invisible as it is hidden under the restored deck.

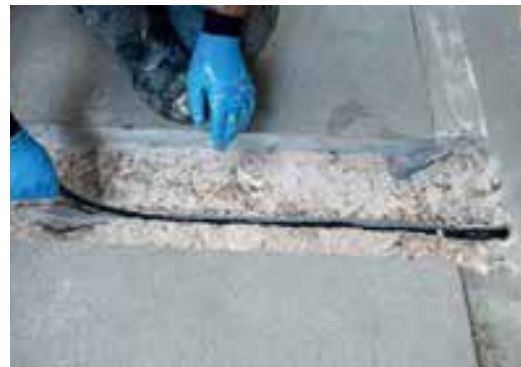
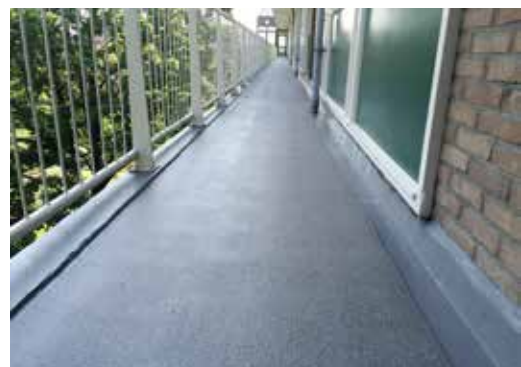
Apartment building in Leeuwarden, The Netherlands

As a result all of these decks were structurally strengthened using SikaWrap® FX carbon fiber strings as Near Surface Mounted (NSM) reinforcement. This Sika system was applied by cutting slots approximately 30 mm deep in the concrete surface, which could be done relatively easily and without any heavy equipment. The ends of these SikaWrap® FX strings were then anchored using Sika AnchorFix® epoxy adhesive, into additional holes drilled into the main structure. The load bearing capacity was therefore increased ensuring future stability and safety.

Once the SikaWrap® FX strings had been installed, the slots were re-filled using a fast-hardening Sika cementitious flooring system. The balcony decks were then sealed and made waterproof to prevent future water and chloride ingress, using a fast-drying Sikafloor® Pronto (acrylate resin based) deck coating system that also provides a range of decorative finishes.

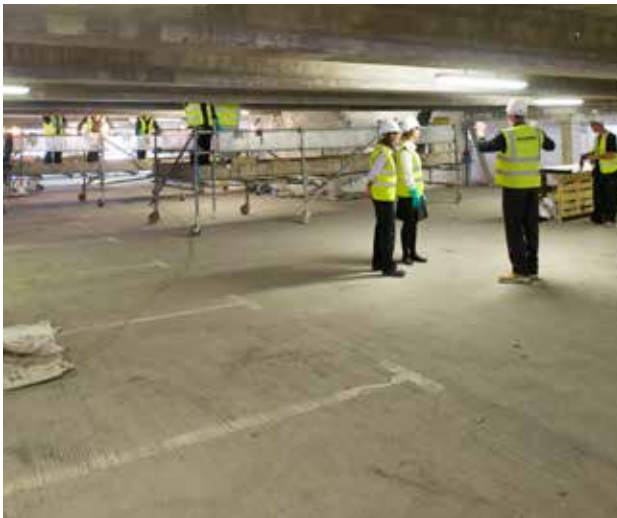
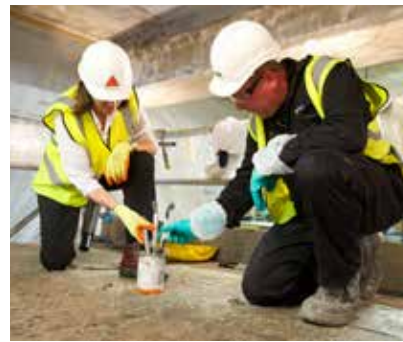
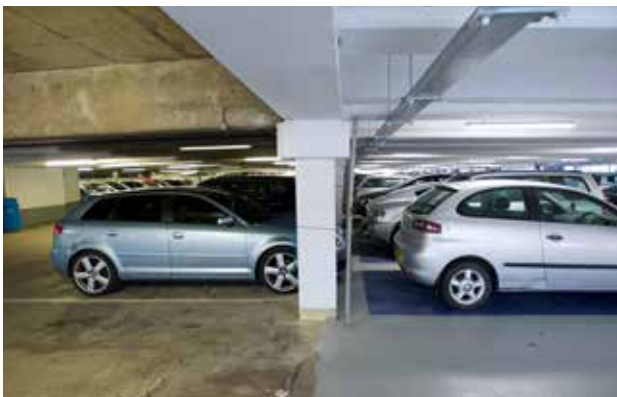
Merrion Centre MSCP, Leeds, UK

During the carbon fiber design phase, the calculations showed a potential peeling issue with the fabric applied on the soffit of the slabs where they met the supporting beams. However this issue was solved by introducing SikaWrap® FX carbon fiber strings as anchors installed into holes predrilled into the beams at an angle of 30° above horizontal, with the SikaWrap® fabric reinforcement then applied and bonded over them.
